Leland Mill Site

Mill Street

Form	912
Town	Sherborn
Area	
USGS Quad	Medfield
Assessor's Sheets	
Ownership	Public
Type Of Structure	Two Mill sites
Constructed	ca. 1860
Source	Tax valuations
Materials	Stone, concrete
Alterations	Concrete raceway built ca.1950 by Jim Leland
Condition	Ruin
Acreage	
Setting	Rural
Recorded by	Sanford Johnson, 3/99
Photographs	Roll 2
Organization	Sherborn Historical Commission

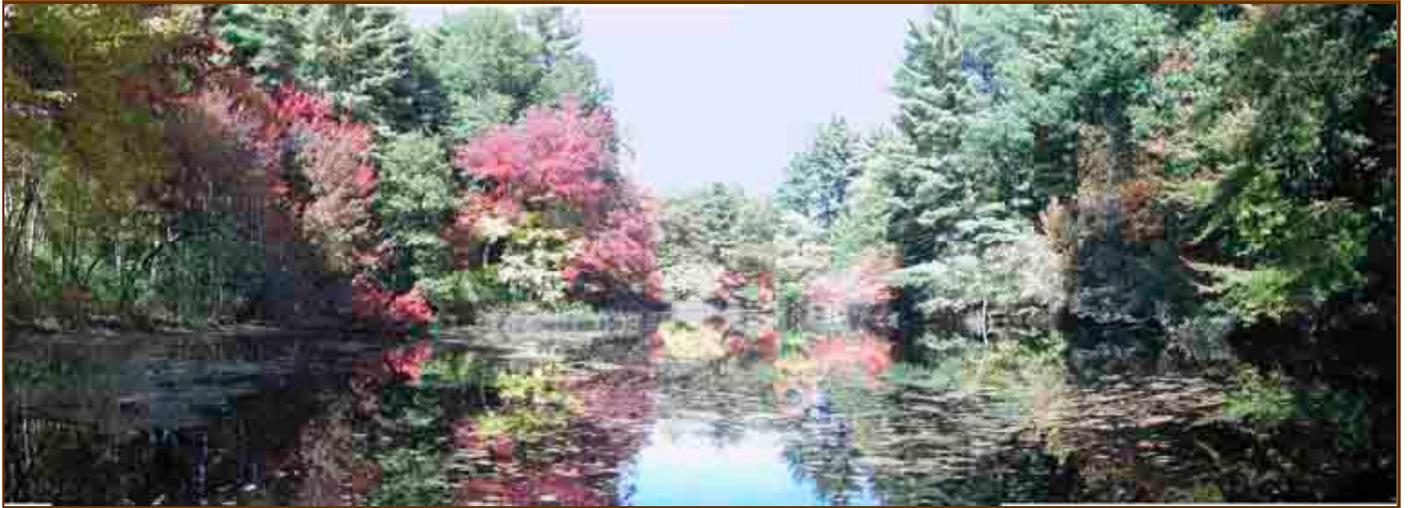
The ruin of the Leland saw and grist mill consists of an earthen, stone and concrete dam retaining a one acre pond. Water flows into the raceway and through walls of uncut mortared stone between four and eight feet in height. Water then flows under a bridge supporting Mill Street which marks the end of the raceway. No evidence of the building survives other than the foundation and raceways. The headrace is a concrete structure still in evidence and comprises the most significant part of the ruin.
