Re: Town of Sherborn – Sherborn Library Project  
December 28, 2016 Construction Contract (Five Star Building Corporation)  
June 15, 2020 Takeover Agreement (Travelers Casualty and Surety Co. of America)  
Performance Bond No. 007-SB-106605907 (Travelers Casualty and Surety Co. of America)  
Notice of Unfair/Deceptive Acts/Practices and Demand for Relief – G.L. c. 93A, § 9

## ARCHITECT'S FIELD REPORT

| <b>PROJECT:</b> SHERBORN LIBRARY Renovations & Addition | <b>FIELD REPORT NO:</b> 49 |

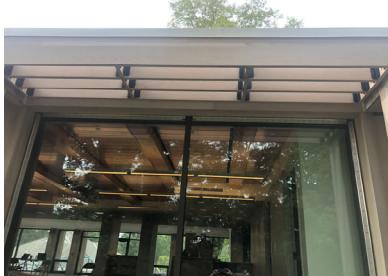
Line 1 CW F-G: cover/sealant removed

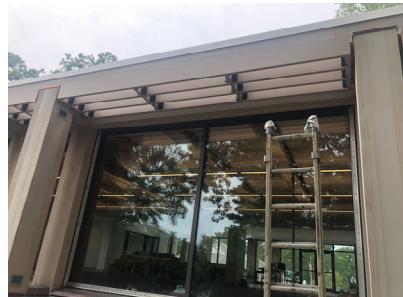
- BCG/Debrino/FSBC determined that the snap on cover could not be removed to install the primary sealant at First Floor CW Bay H-J and K-L because the joint does not exist at these heads for the proper installation of a backer rod & sealant.

Line 1 CW H-J & K-L: covers/sealant NOT removed @ heads

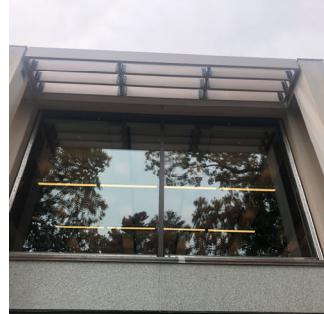
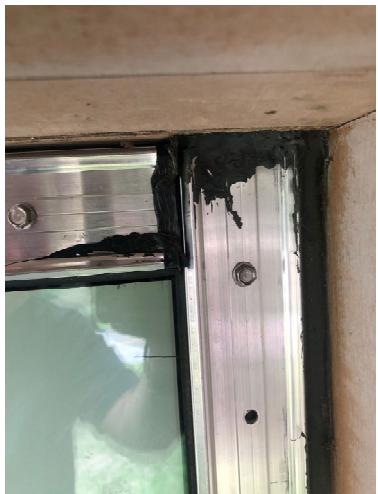
Line 1 CW F-G: (+/-)1/4" max exist joint

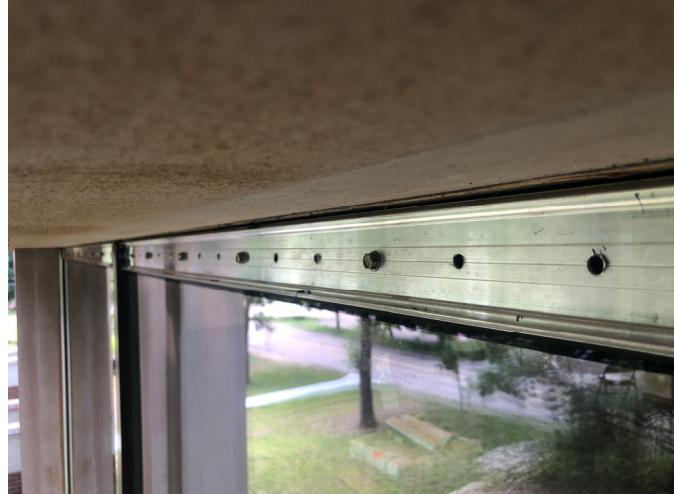
Line 1 CW F-G: Primary sealant cannot be installed - exist joint @ (+/-) 1/4" to 0"

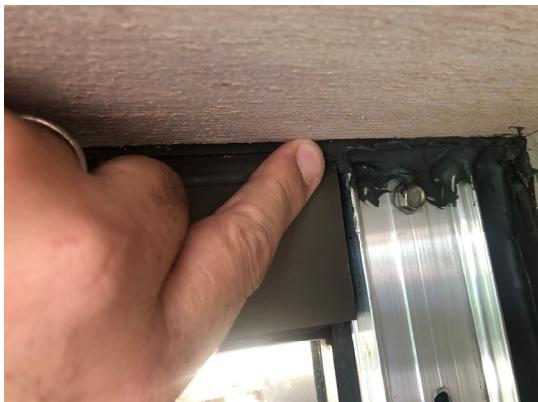
- The cedar board of the horizontal soffit butts to the top face of the aluminum curtainwall frame @ the north side jamb of CW Bay H-J and the cedar board butts +/- 1/4" below the top of the aluminum curtainwall frame at the south side jamb.

- The cedar board of the horizontal soffit butts +/- 1/8" below the top of the aluminum curtainwall frame at the north side jamb and butts +/- 3/8" below the top of the aluminum curtainwall frame at the south side jamb.

Line 1 CW H-J: Snap on cover cannot be removed. 1. The cedar board of the horizontal soffit butts to the top face of the aluminum curtainwall frame @ the north side jamb. 2. The cedar board butts +/- 1/4" below the top of the aluminum curtainwall frame at the far south side jamb. 3. There is no head joint/reveal for the primary sealant. The cedar board butts directly to aluminum curtainwall frame and the sealant/residue is only left on the aluminum curtainwall frame.

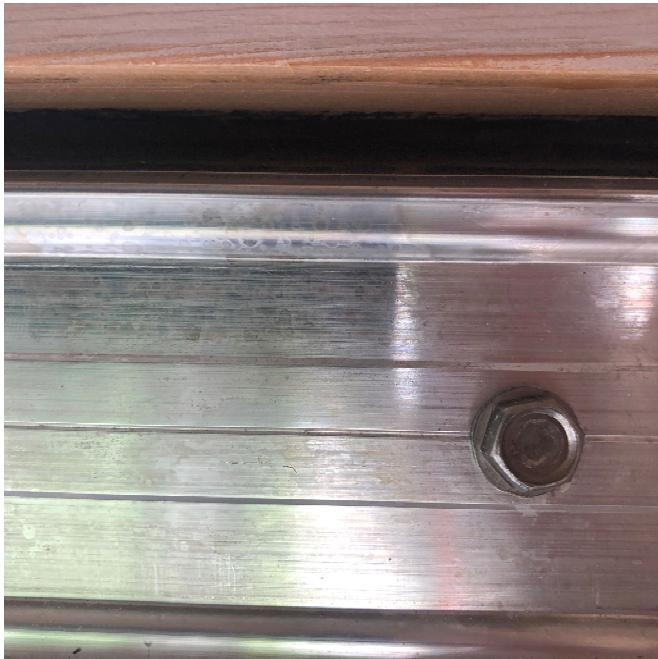
- Observe cut underside of exterior finish cedar board at bulkhead does not appear to have been finished/stained. BCG to seal/stain all cut cedar as specified, see also BCG/BAA 7/29/2021 emails regarding "Window Header".
- Proper installation and adhesion of the head backer rod and sealant to suitable surfaces (with no gaps) at the head primary sealant joint shall be confirmed/clarified by BCG @ the underside of the added bulkheads along 6.9-Line. Verify cedar/wood rough ends and/or cut ends; verify if gaps at shims for backer rod/sealant adhesion/support. See *Observations #3 (below)*.

**Line 6.9 CW F-G & K-L:** Cut wood at underside of bulkhead. BCG to verify that cut finish cedar board has been properly finished/stained as specified. BCG to verify primary sealant adhesion on cut wood at underside of bulkhead.

- 7) BCG to seal/stain all cut cedar as specified, see also BCG/BAA 7/29/2021 emails regarding "Window Header".
- 8) BCG to finish sanding remaining areas to remove sealant residue on cedar boards. BCG to provide a stain mock-up @ 6.9-Line CW Bay jamb for BAA on-site review.

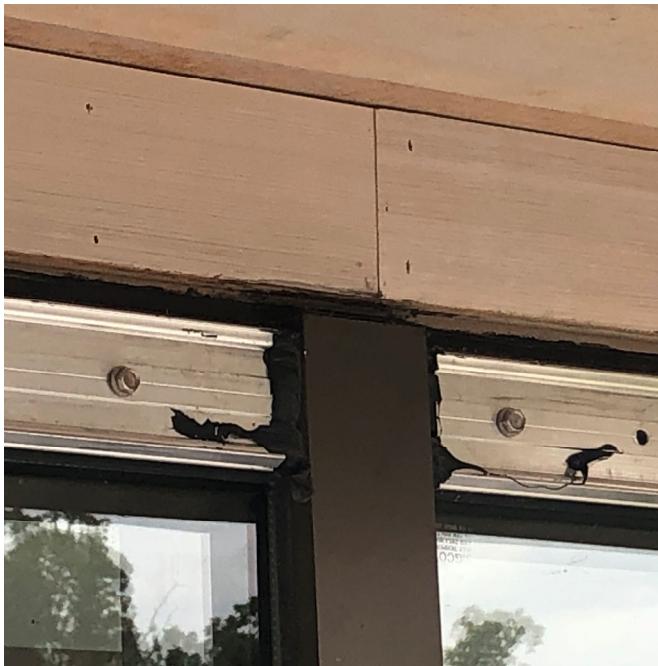
- Aluminum CW Bay F-G @ 6.9-Line: cedar board set back +/- 1/8" from face of aluminum curtainwall.
- Aluminum CW Bay K-L @ 6.9-Line: cedar board aligns with face of aluminum curtainwall.
- Aluminum Storefronts @ 6.9-Line: cedar board & 1/4" shims not added above storefronts? BCG to add cedar board finish as required to align w/face of aluminum storefronts.

**Line 6.9 CW F-G & K-L:** Finished cedar board at bulkhead to align with face of aluminum curtainwall frame.

- 5) BCG to add cedar board finish as required to align w/face of aluminum storefront at non-conforming bulkheads located above 6.9-Line storefronts. Remove/replace backer rod & sealant @ storefront heads as required.

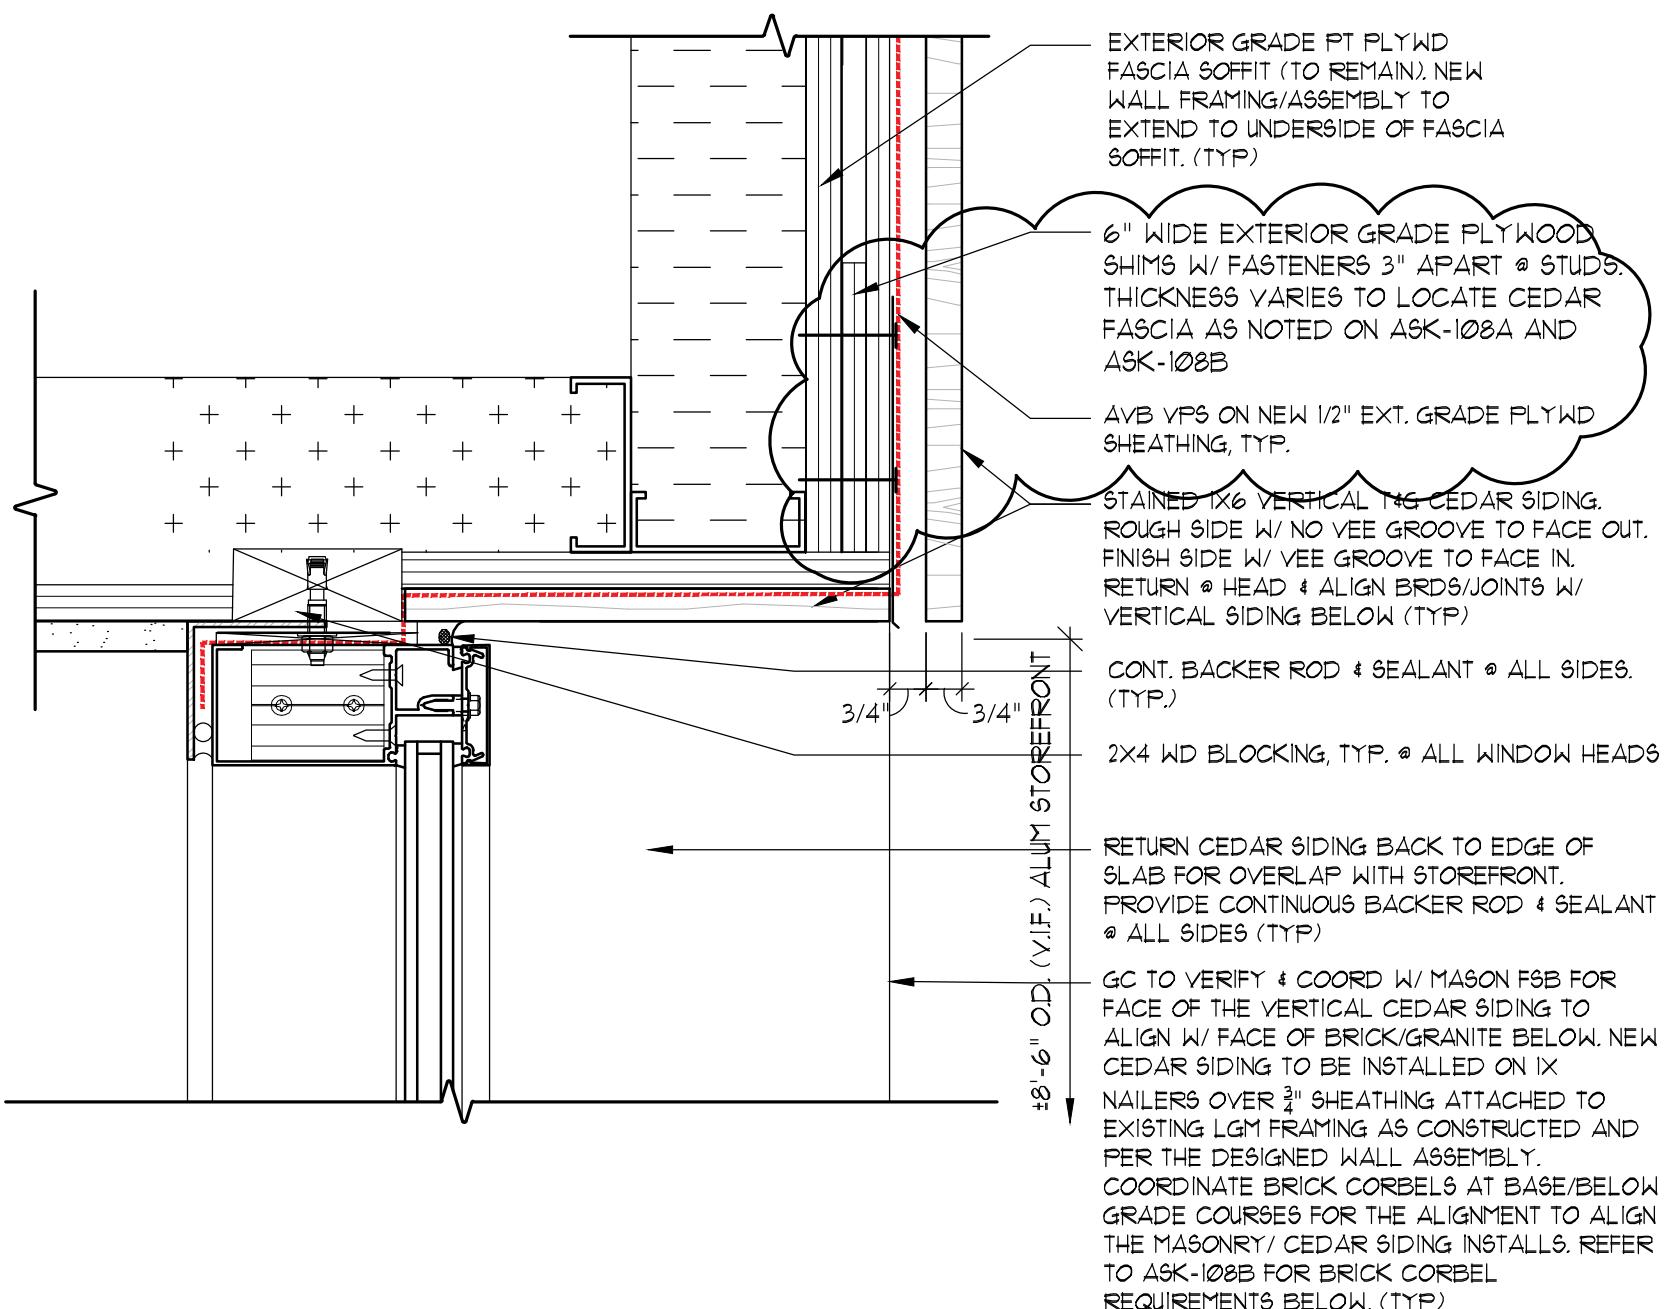
### SOFFIT DETAIL @ 1 LINE

- BAA reviewed with BCG/Debrino/FSBC ASK-108-BR1 & ASK-108-DR1 dated 6/15/2021 for the typical curtainwall head configuration detail along the 1-Line horizontal cedar board soffit, indicating the head joint with continuous perimeter backer rod & primary sealant to be installed. As reviewed and observed, the curtainwall head assemblies and soffit layouts/configurations do not conform to the design documents. See ASK-108-BR1 & ASK-108-DR1 dated 6/15/2021.
