RE: #0 Washington Street – Soil Testing

## Form 11 - Soil Suitability Assessment for On-Site Sewage Disposal

LOT 3 SOIL TEST LOCATION PLAN  
AT  
LOT 3 - WASHINGTON STREET  
IN  
SHERBORN, MA

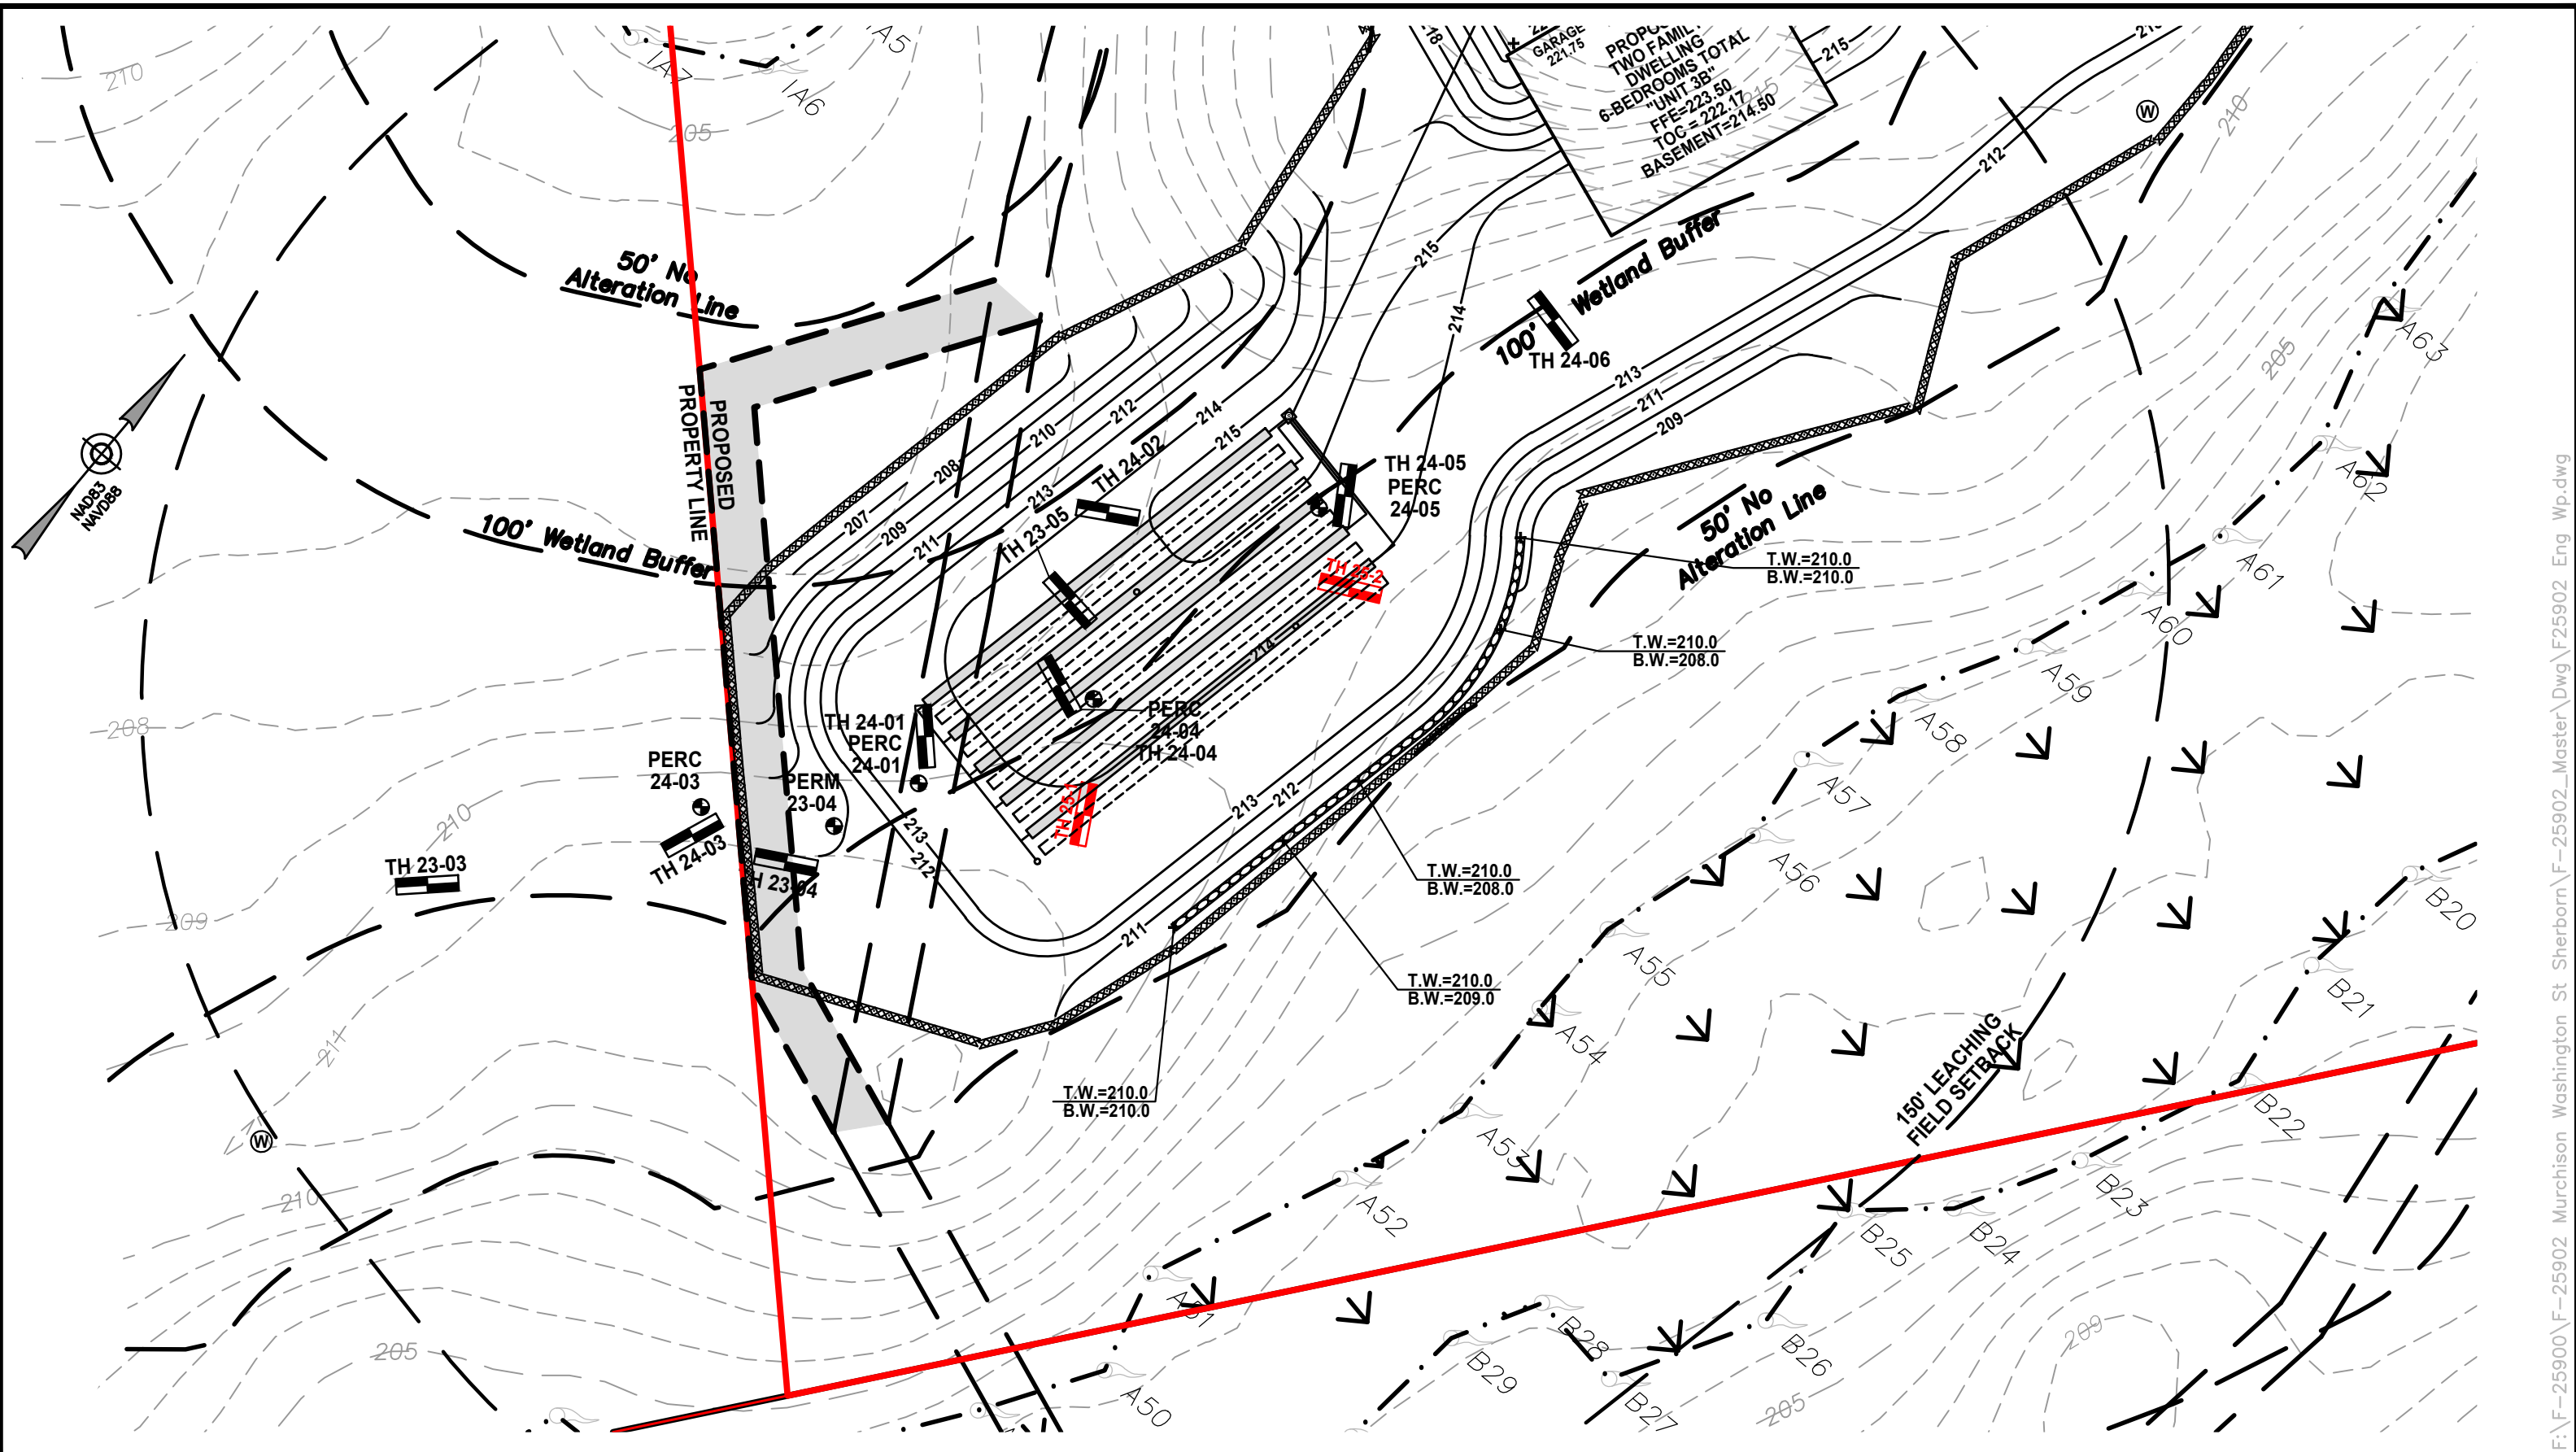
ST-1

The Test Holes generally revealed a fine sandy loam topsoil over a firm sandy loam substratum. The soil test logs and Soil Test Hole Location Plan are contained in Attachment #1 and Attachment #2 respectively.
