Re: Town of Sherborn – Sherborn Library Project  
December 28, 2016 Construction Contract (Five Star Building Corporation)  
June 15, 2020 Takeover Agreement (Travelers Casualty and Surety Co. of America)  
Performance Bond No. 007-SB-106605907 (Travelers Casualty and Surety Co. of America)  
Notice of Claim for Contract Indemnification and  
Notice of Unfair/Deceptive Acts/Practices and Demand for Relief – G.L. c. 93A, § 9

## FIELD REPORT

**Project Name /Location:** Sherborn Library

**Field Report No:** 583

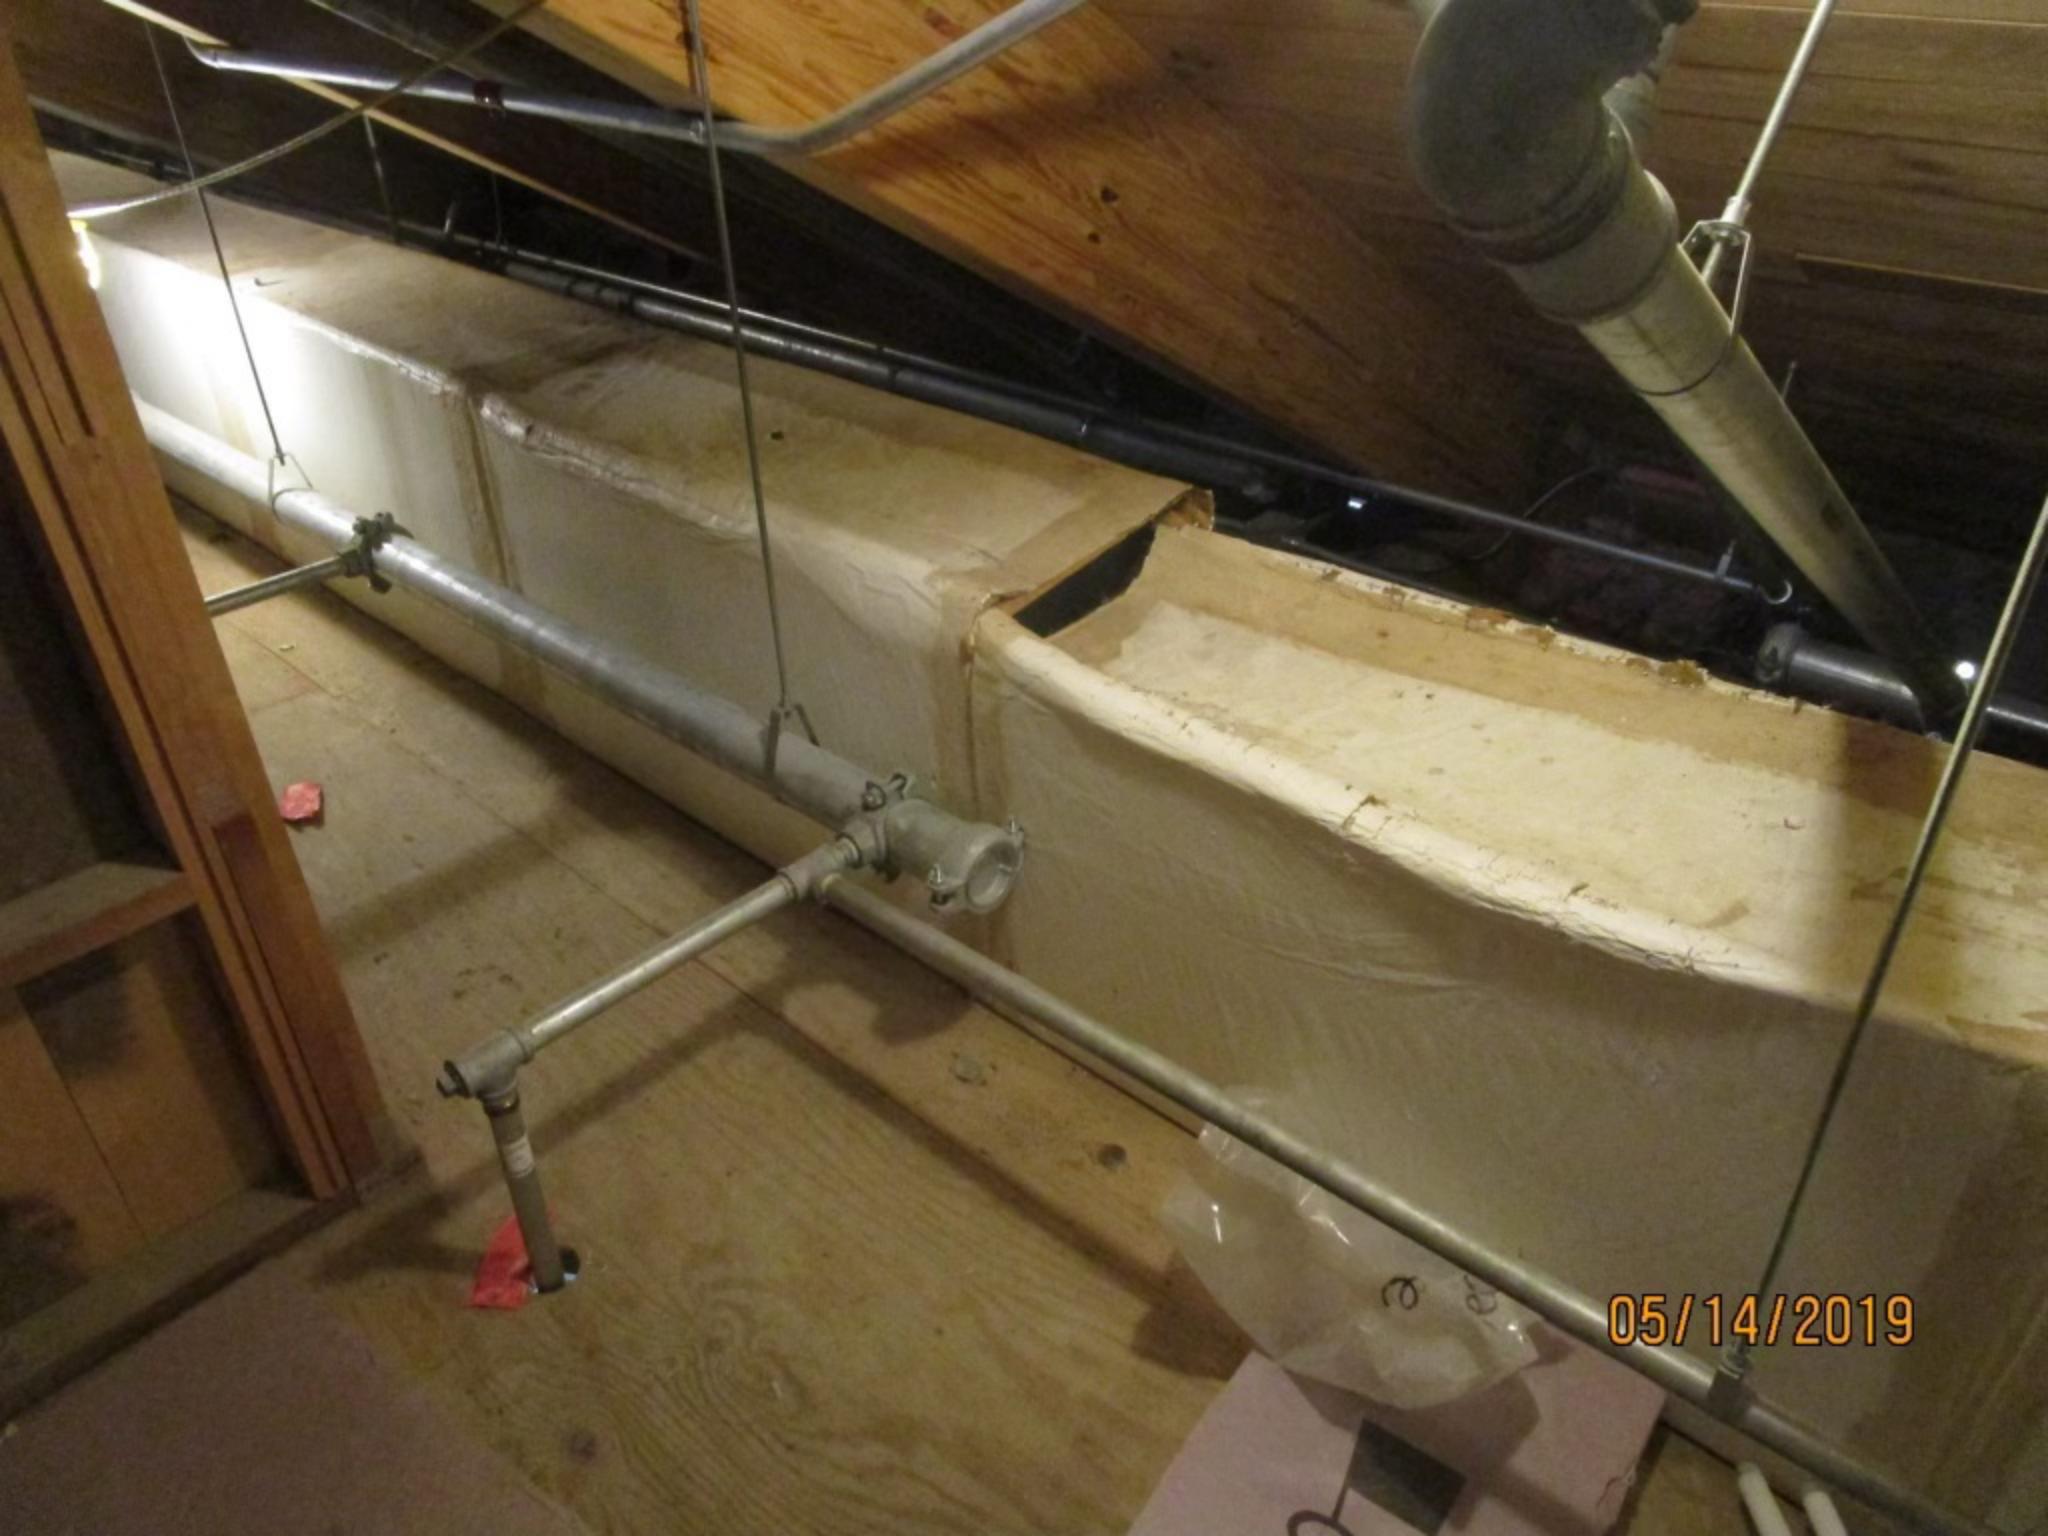
05/14/2019

The ductwork damage was caused by Five Star. As reflected in the enclosed September 4, 2019 Field Report 583 from the Town's former project manager, which was distributed to Five Star, damaged ductwork was discovered in the building in 2018 and "FSBC" was to correct that damage. Obviously, Five Star never did. Nor did Five Star ever assert that the Town (or any separate contractor) was responsible for the damage. If Five Star believed it was not responsible for the ductwork damage noted in Field Report 583, it certainly had plenty of time to make that belief known. It never did, and the time to do so has long since passed under the provisions of the contract (see, e.g., General Conditions, Articles 6 and 15). Whether Five Star's silence is deemed an admission of responsibility or waiver of a right to object, Travelers is bound thereby. Therefore, Five Star cannot honestly deny responsibility for the damaged fiberboard ductwork in the Sherborn Library building.

Travelers' allegations are contrary to Field Report 583 and other available evidence. For example, adjacent to each item of damaged ductwork, fire sprinkler pipes and electrical wiring/conduit had been installed by Five Star. In order for that work to occur, Five Star's electrical and fire protection subcontractors would have had to move materials over the top of the ductwork. Travelers' assertion that the Town's IT contractor, which hung light-weight cabling on the underside of the roof interior, damaged the ductwork is unpersuasive and unsupported by the available evidence. An example is the enclosed copy of a photograph of damaged ductwork before any cabling had been installed.
