# 86 Brush Hill Road

**Form No.** 193, 194-barn; 195-coop; 196-shed

**Town** Sherborn

**Address** 86 Brush Hill Road  
**Assessor's #** 1/12  
**USGS Quad** Framingham

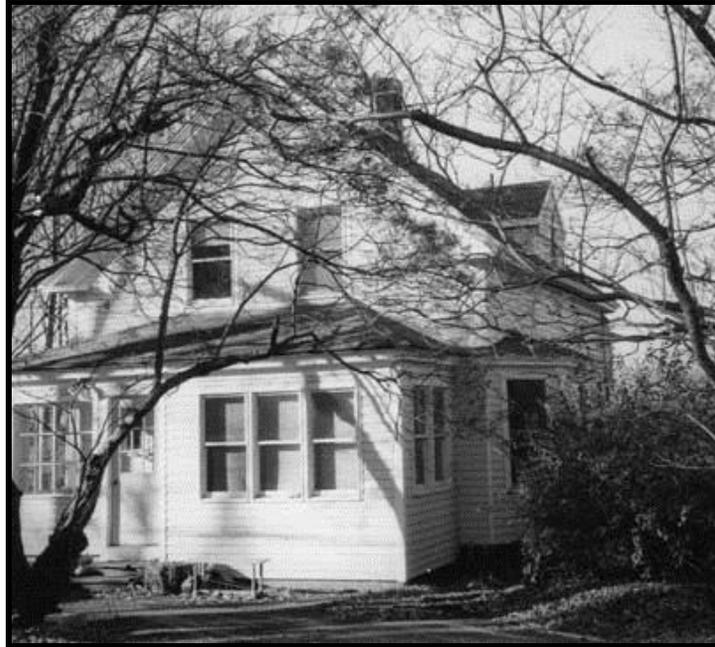
*86 Brush Hill Road, May 1999*

Eighty-six Brush Hill Road is a front-gabled, one and one-half-story Victorian Eclectic style residence, formerly used as a farm. The three by two bay plan is expanded by an enclosed hipped front porch and one-story bay window at the right (east) side. A gabled dormer and central crick chimney mark the roofline. Decorative elements include the gable returns, corner boards and molded cornice. Windows are modern, single pane double hung units with simple trim, probably installed during the recent rehabilitation with the door in the side-hall porch entry. The house at 86 Brush Hill road has undergone rehabilitation within the last two years and is in excellent condition. The barns are in good condition. The barn bears a strong resemblance to the barn at **46 Western Avenue** \*\*. The lot is wooded and appears to have a view to the north.
