42 Washington Street

Grout Farm

Form Nos.	153 house, 356 barn, 928 silo, 929 fence Shop/"Cider mill"
Area	
Town	Sherborn
Address	42 Washington Street
Assessor's Map	7/91
USGS Map	Medfield
Historic Name	Grout Farm
Uses: Original	Residence
Present	Residence
Ownership, 1981	Frances Grout
" Original	Robert Grout
Constructed	House in 1859, barn ca. 1875, silo and fence ca. 1900
Source	Margaret Dowse Buntin's research
Style/Form	Mid 19th century frame vernacular
Architect	
Ext. Wall Fabric	Clapboard
Outbuildings	Barns and "little house"
Alterations	1930's or 1940's fire destroyed central pavilion's attic and portion of northeast wing.
Moved	No
Acreage	15.70 acres
Setting:	Ample lawn slopes from house to Washington Street, smaller house adjacent to northeast wall, barns to southwest.

Recorded July 1981, by Edward W. Gordon
Updated 1999, by Sanford Johnson

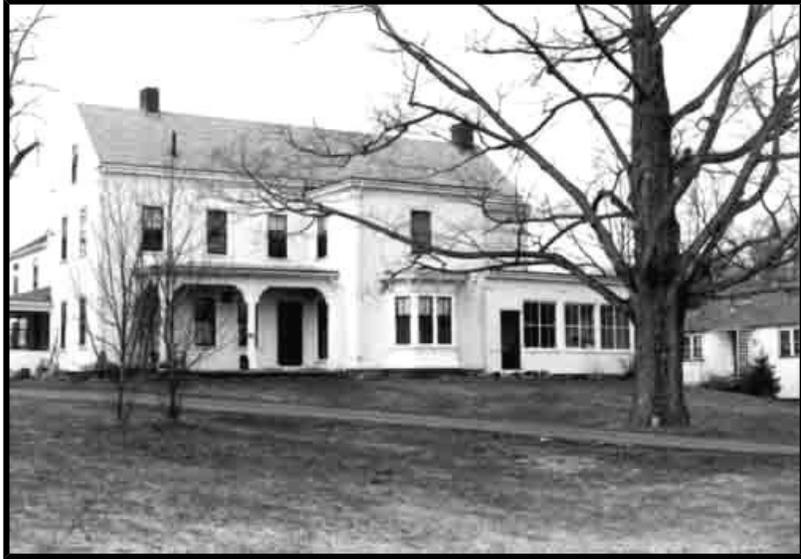
The Grout Farm on Washington Street is two and one half-story, side-gabled form with a prominent two-story projecting central gabled bay. The seven by two-bay plan is expanded at the rear (northwest) by a one-story ell and attached two-bay garage, added in the 1990s. Hipped porches flank the central bay and cover the first story of the facade. Windows are primarily 2/2 double-hung sash with beaded trim. Those in the central bay are further articulated with half-round hoods. The ground story of the bay is lit by a three-sided bay window with brackets at the molded cornice. Two entries exist on the facade. The left side of the bay has a single door lit by two tall panes. The right side has a double-leaf door, also with ornamental sash. Decorative elements consist of the bracketed, molded cornice, gable returns, jigsawn brackets supporting the porches and corner boards. Two low brick chimneys mark the ridgeline. The house is nearing the end of a major rehabilitation project that included historically sensitive window replacement, reconstruction of the roof of the central bay, addition of a garage in the rear and construction of several stone walls in the front , side and rear yards.
