SETTLEMENT AGREEMENT AND RELEASE

WHEREAS, on December 28, 2016, the Town and Five Star entered into a construction contract for the public construction project known as the Sherborn Public Library Renovation and Addition (such contract, as amended, the “Original Contract,” and such project, the “Project”); and

EXHIBIT A
FLASHING REPAIRS
(Exhibit follows this Page)

Re: Flashing Repairs
Sherborn Library
Sherborn, MA

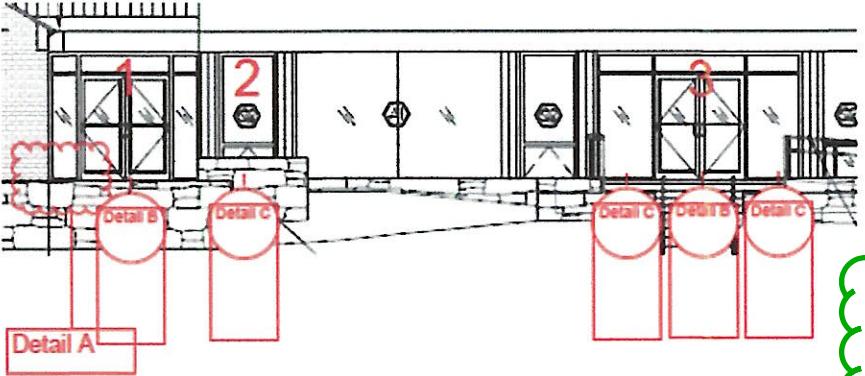
West Elevation- Not to Scale

Scope of Work:

- Openings 1,2,3 to be removed by others.
- Excavation/Demo to allow DeBino to perform work for repair by others.
- Repair of Substrate (Patching and Parging) to provide a smooth sound surface by others.

- Repair of opening 1 to utilize a combination of details 9/A403 and details provided by Peter on 6/15/23 6.9 Flashing Termination Detail and 6.9 Details at Door Provided on 2/15/23 and on site discussion with Peter on 6/15/23.

- Repair of Opening 2 will utilize detail 9/A403.
- Repair of Opening 3 will utilize detail 9/A403 and Details at Door provided on 2/15/23.
- If additional openings are to be removed based on the conditions repair details will be determined at that time.

- Removal of Openings 1,2 and 3 has potential and is likely to damage existing Air Vapor Barrier at the openings. This will need to be addressed as well. As the caulking around the openings.

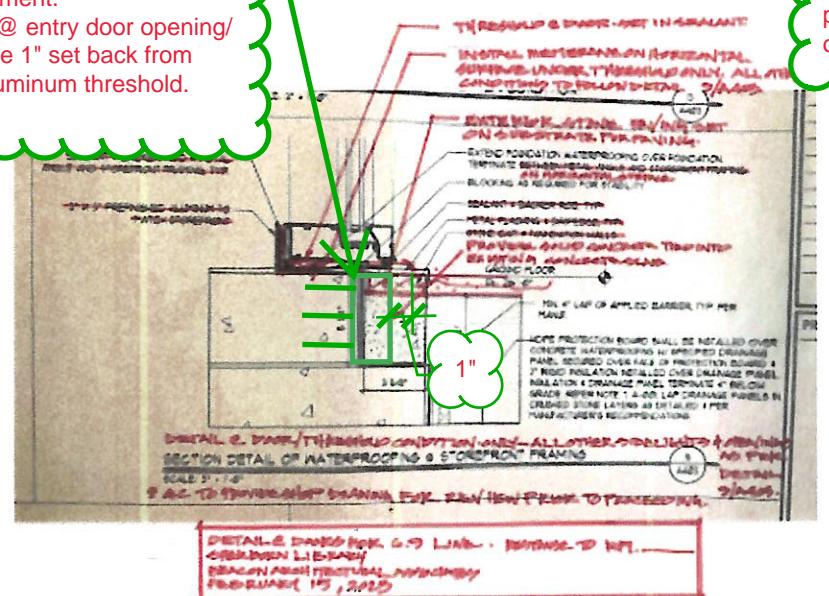
Detail A

Roughen existing slab face & conc surfaces & apply bonding agent prior to installing epoxy cement.

Extend slab edge @ entry door opening/ threshold to provide 1" set back from leading edge of aluminum threshold. (TYP)

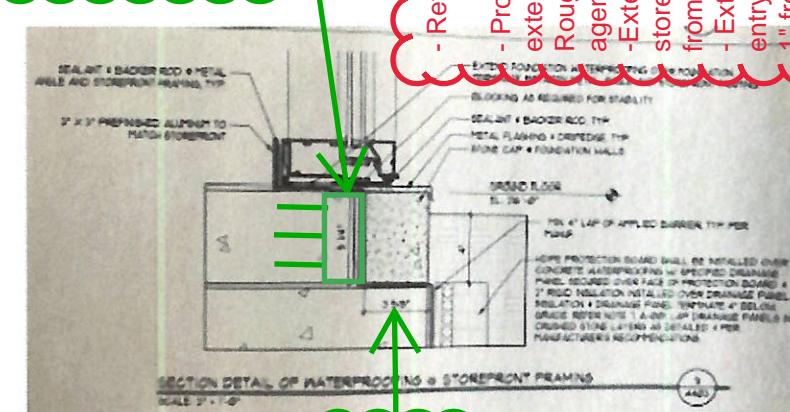
Detail C

Patch in new formed epoxy cement extension @ existing slab edge. Roughen existing slab face & conc surfaces & apply bonding agent prior to installing epoxy cement. Extend @ storefronts and entry side lights to provide a 3 5/8" set back from the face of foundation wall. (TYP)

Refer to PCB comments clouded

- Provide & patch new formed epoxy cement extensions @ the existing slab locations.
- Roughen existing surfaces & apply bonding agent prior to installing epoxy cement (TYP)
- Extend slab edge w/ epoxy cement @ storefronts and entrance side lights to 3 5/8" from face of foundation wall. (See Detail C)
- Extend slab edge w/ epoxy cement @ entry door opening/threshold to be set back 1" from leading edge of aluminum threshold. (See Detail B)

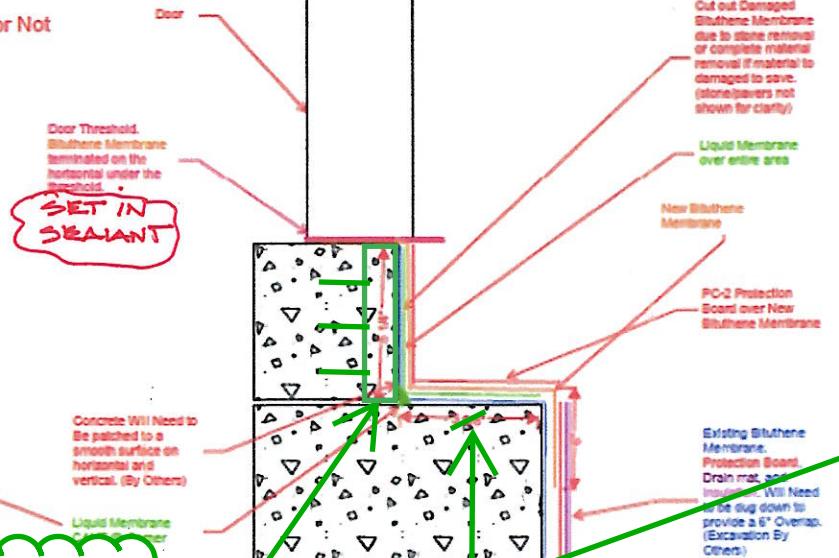
Door Detail REF Detail B - Detail at Door Provided on 2/15/23- Not to Scale

Existing Brick Parged Smooth (by others) where reusing new Bituthene membrane.

Bituthene Membrane tie onto existing brick for form "pan" as requested by Mark on site 6/14/23 during discussion

Bituthene Membrane tie onto Horizontal below door threshold/storefront. Door Not Shown for Clarity

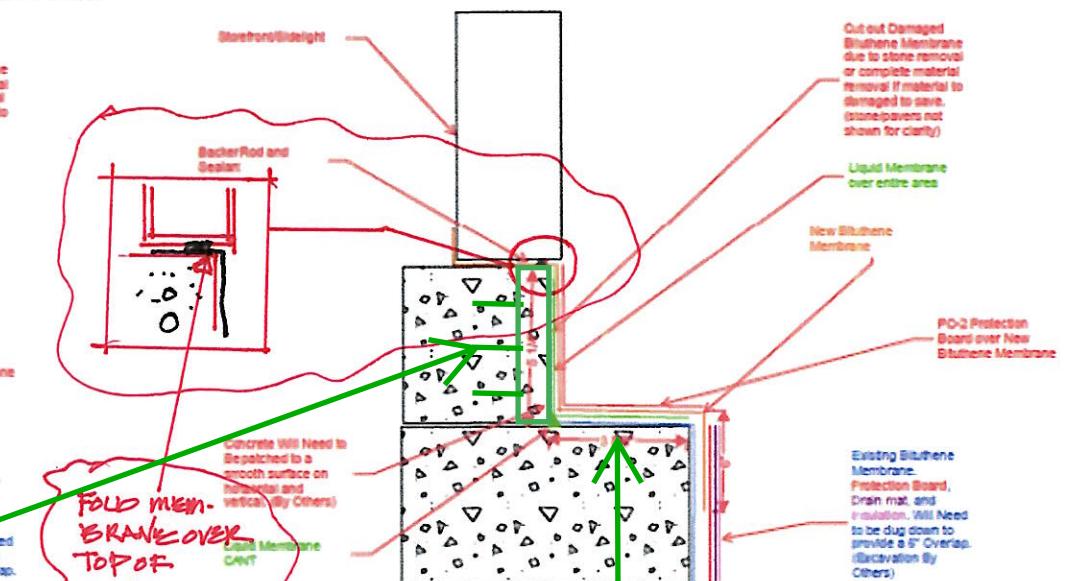
Storefront/Sidelight REF Detail C - Architectural Drawing 9/A403- Not to Scale

- Extend @ storefronts & entrance side lights to 3 5/8" from face of foundation wall.

Termination Bar Set Below Line of Finish Piso

New Bituthene Membrane. All set in Liquid Membrane. Drainage Board, Protection Board, Insulation Not Shown for Clarity. 6" Tie onto Existing Membrane

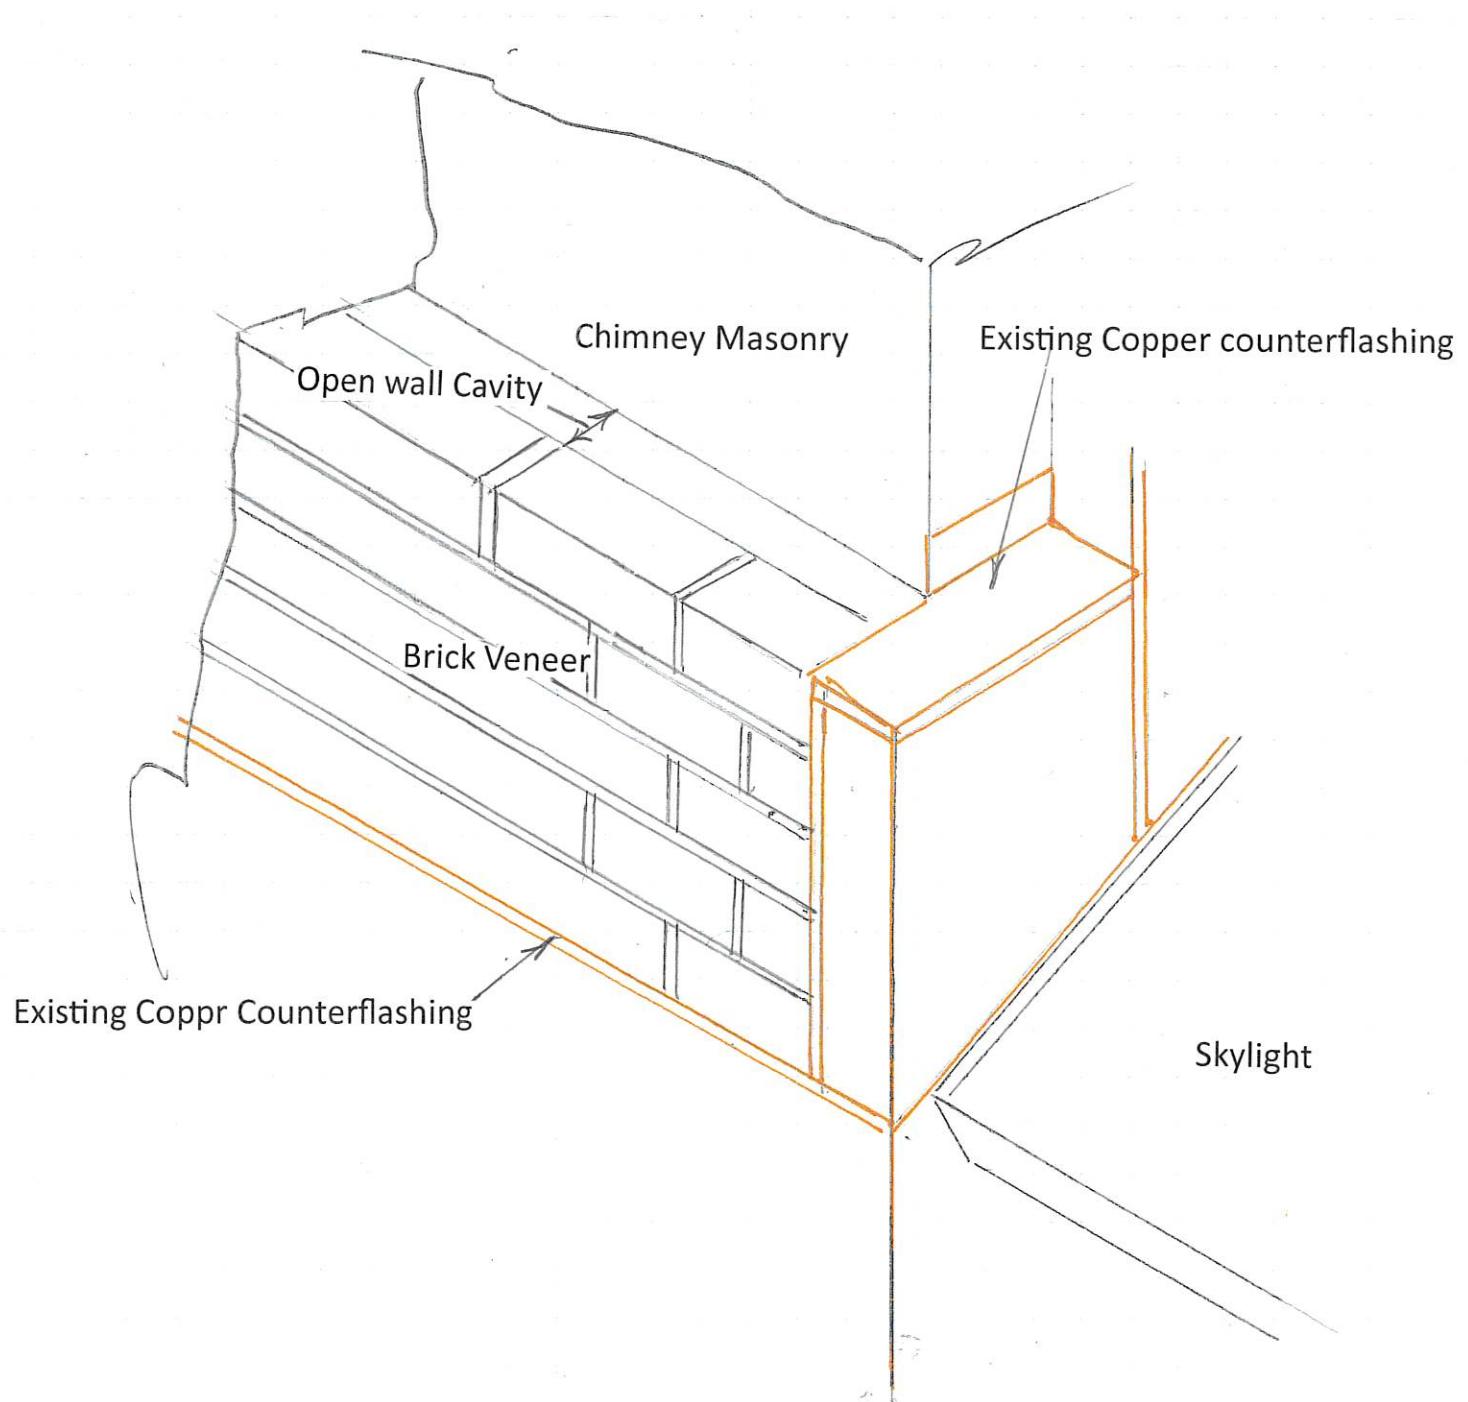
SKETCH 1 BASED ON WALL OPENING

We transmit herewith five sketches showing the existing condition and our recommendation for repairs to the copper step flashing in the south chimney southside at the skylight discovered in the last series of water tests and wall opening.

West Chimney-South Side

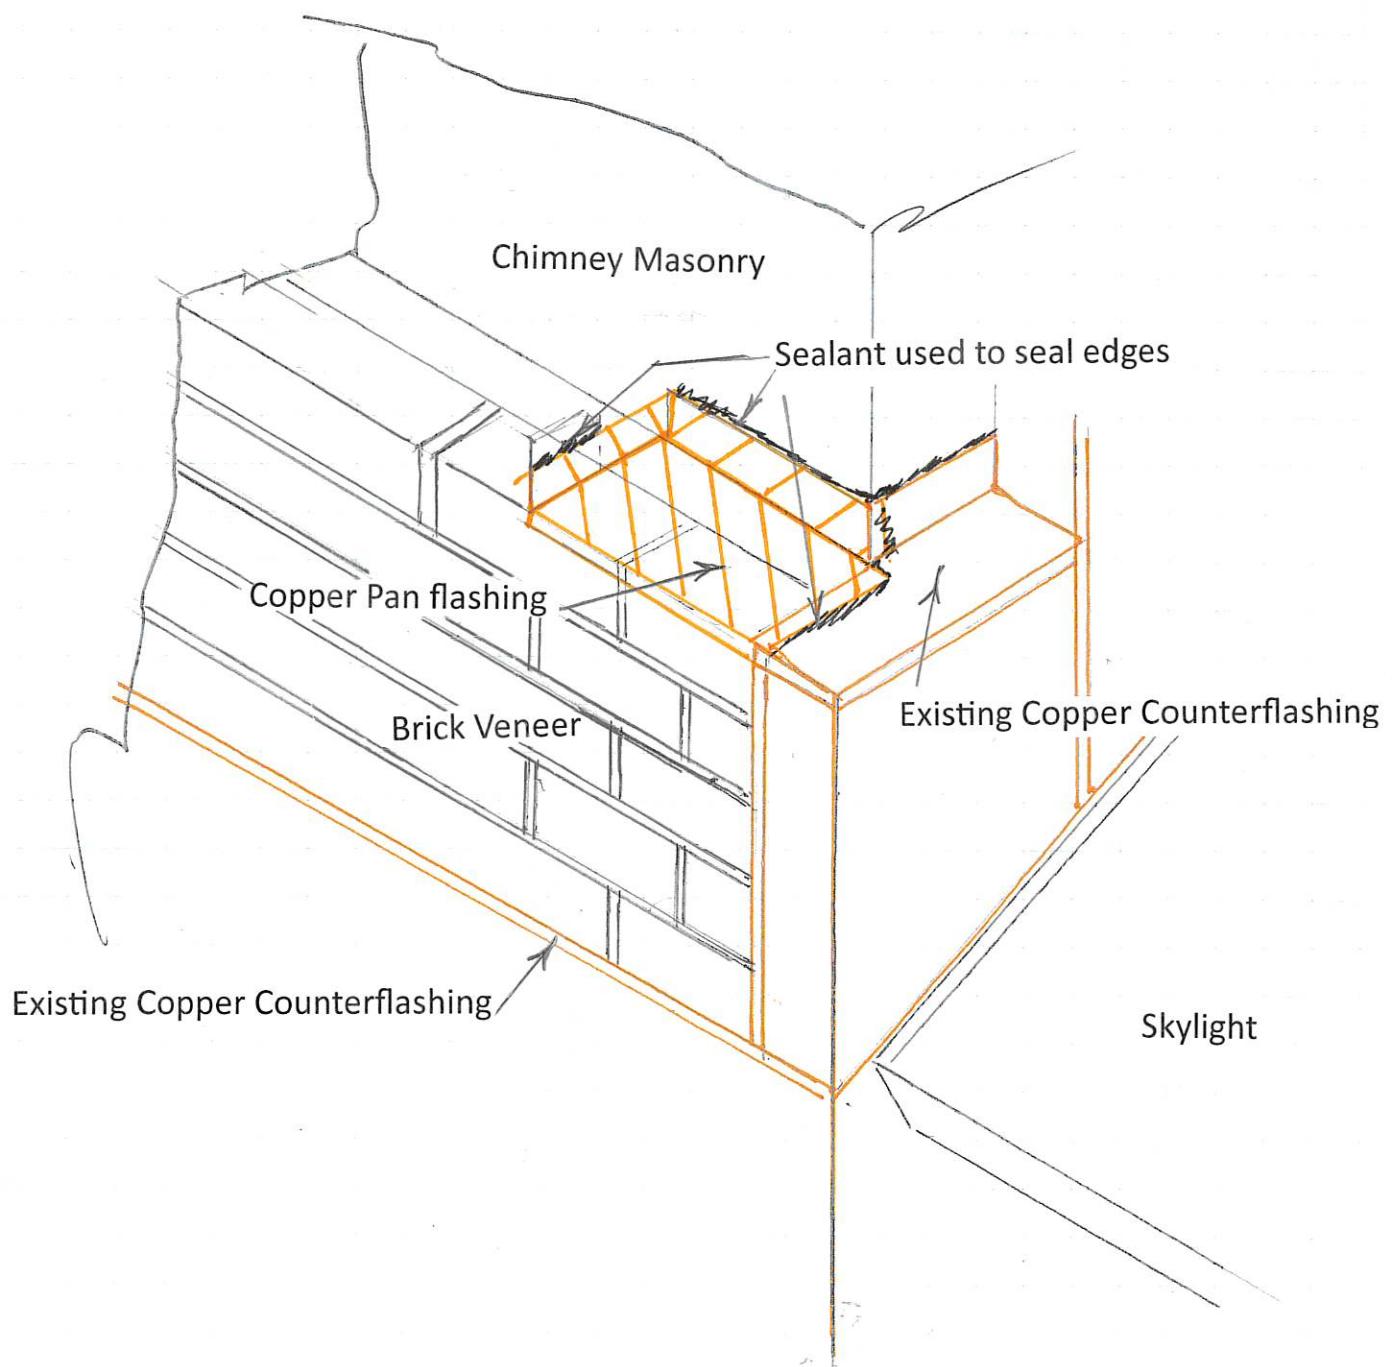
SKETCH TEMPORARY FLASHING REPAIR

West Chimney-South Side

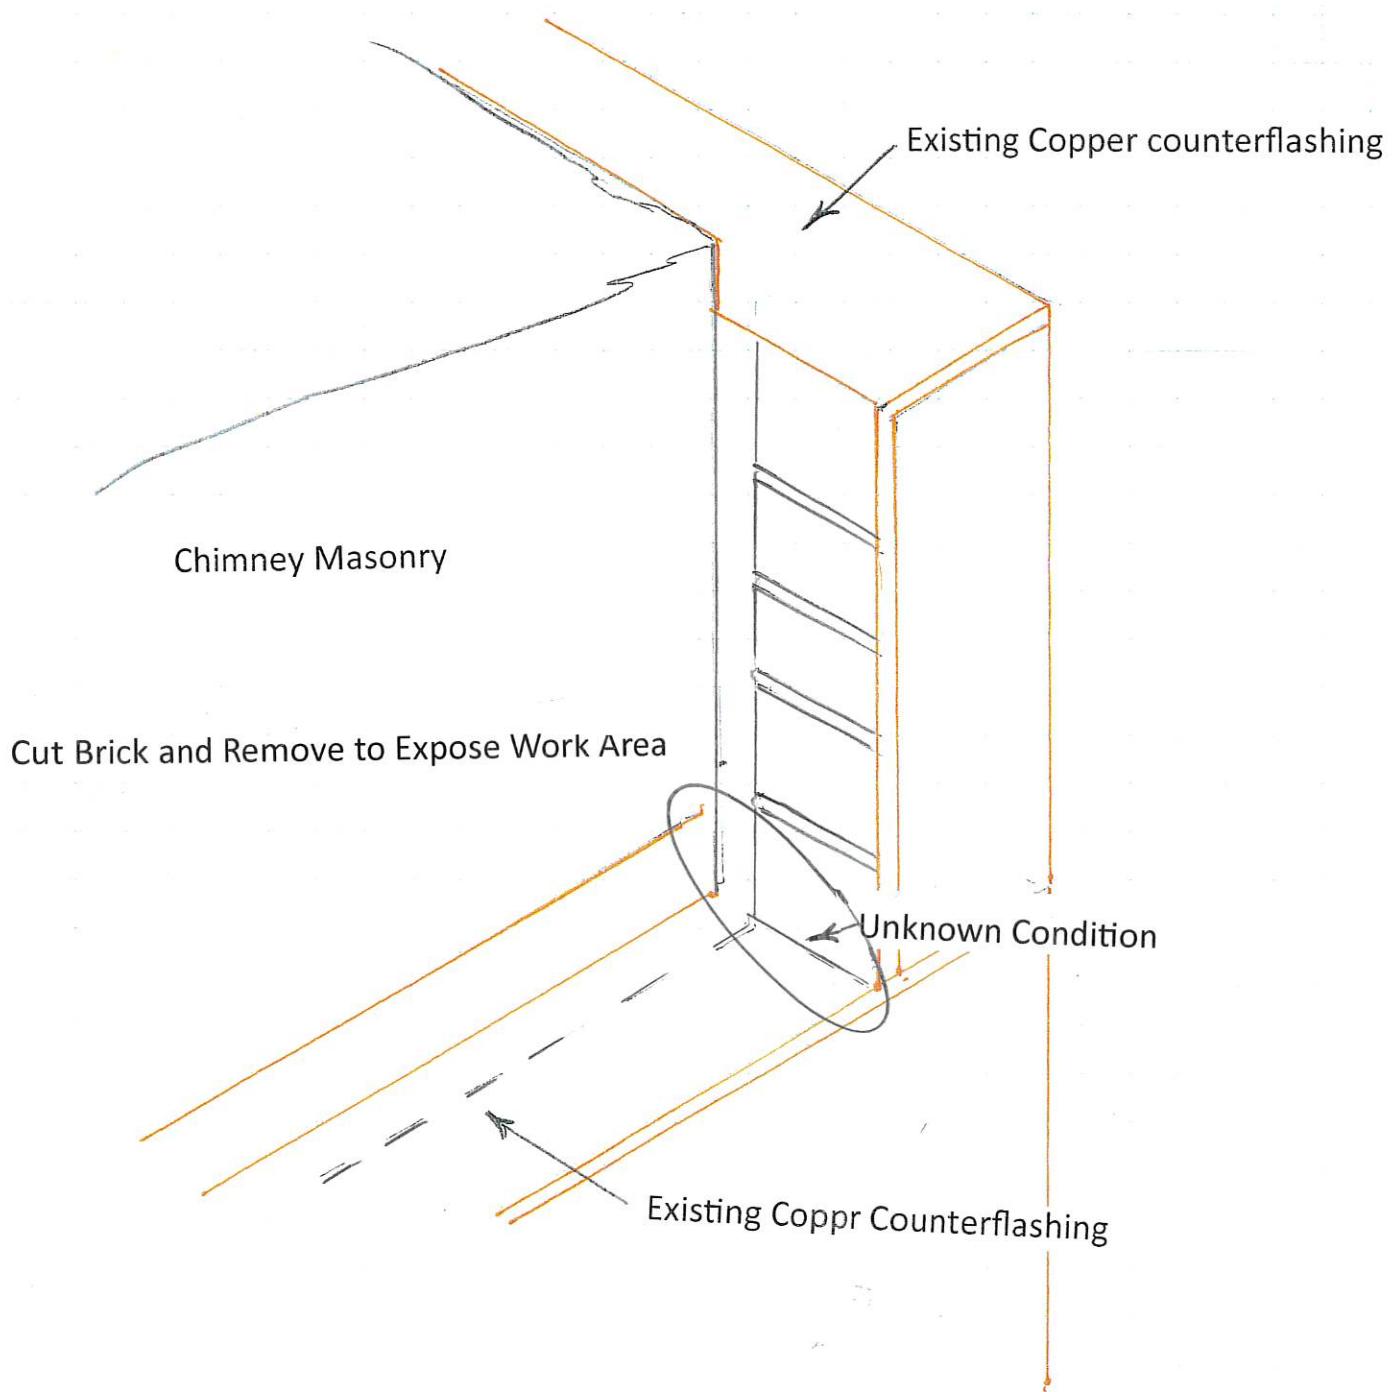
SKETCH 3 ADDITIONAL FLASHING STEP 1

West Chimney-South Side

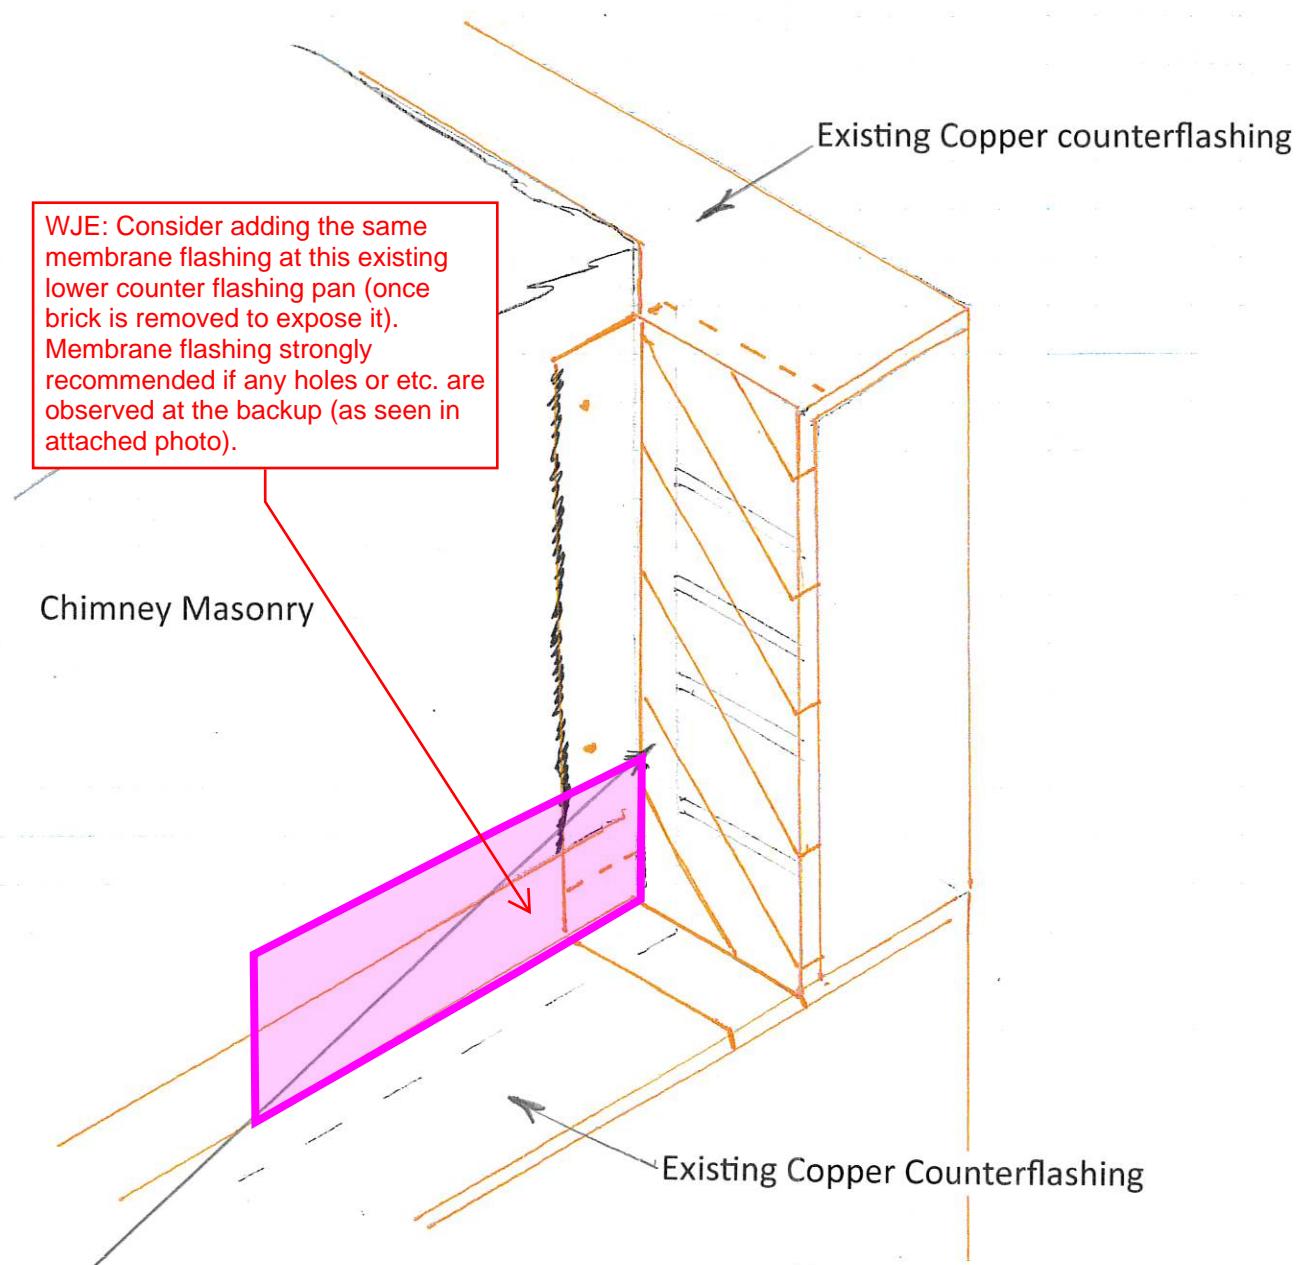
SKETCH 4 ADDITIONAL FLASHING STEP 2

West Chimney-South Side

Vertical Copper Flashing fasten to chimney masonry, lock into Vertical locked seam on surface, solder seams at upper and lower counter flashings, seal edge of copper to the chimney masonry.
Reinstall brick masonry

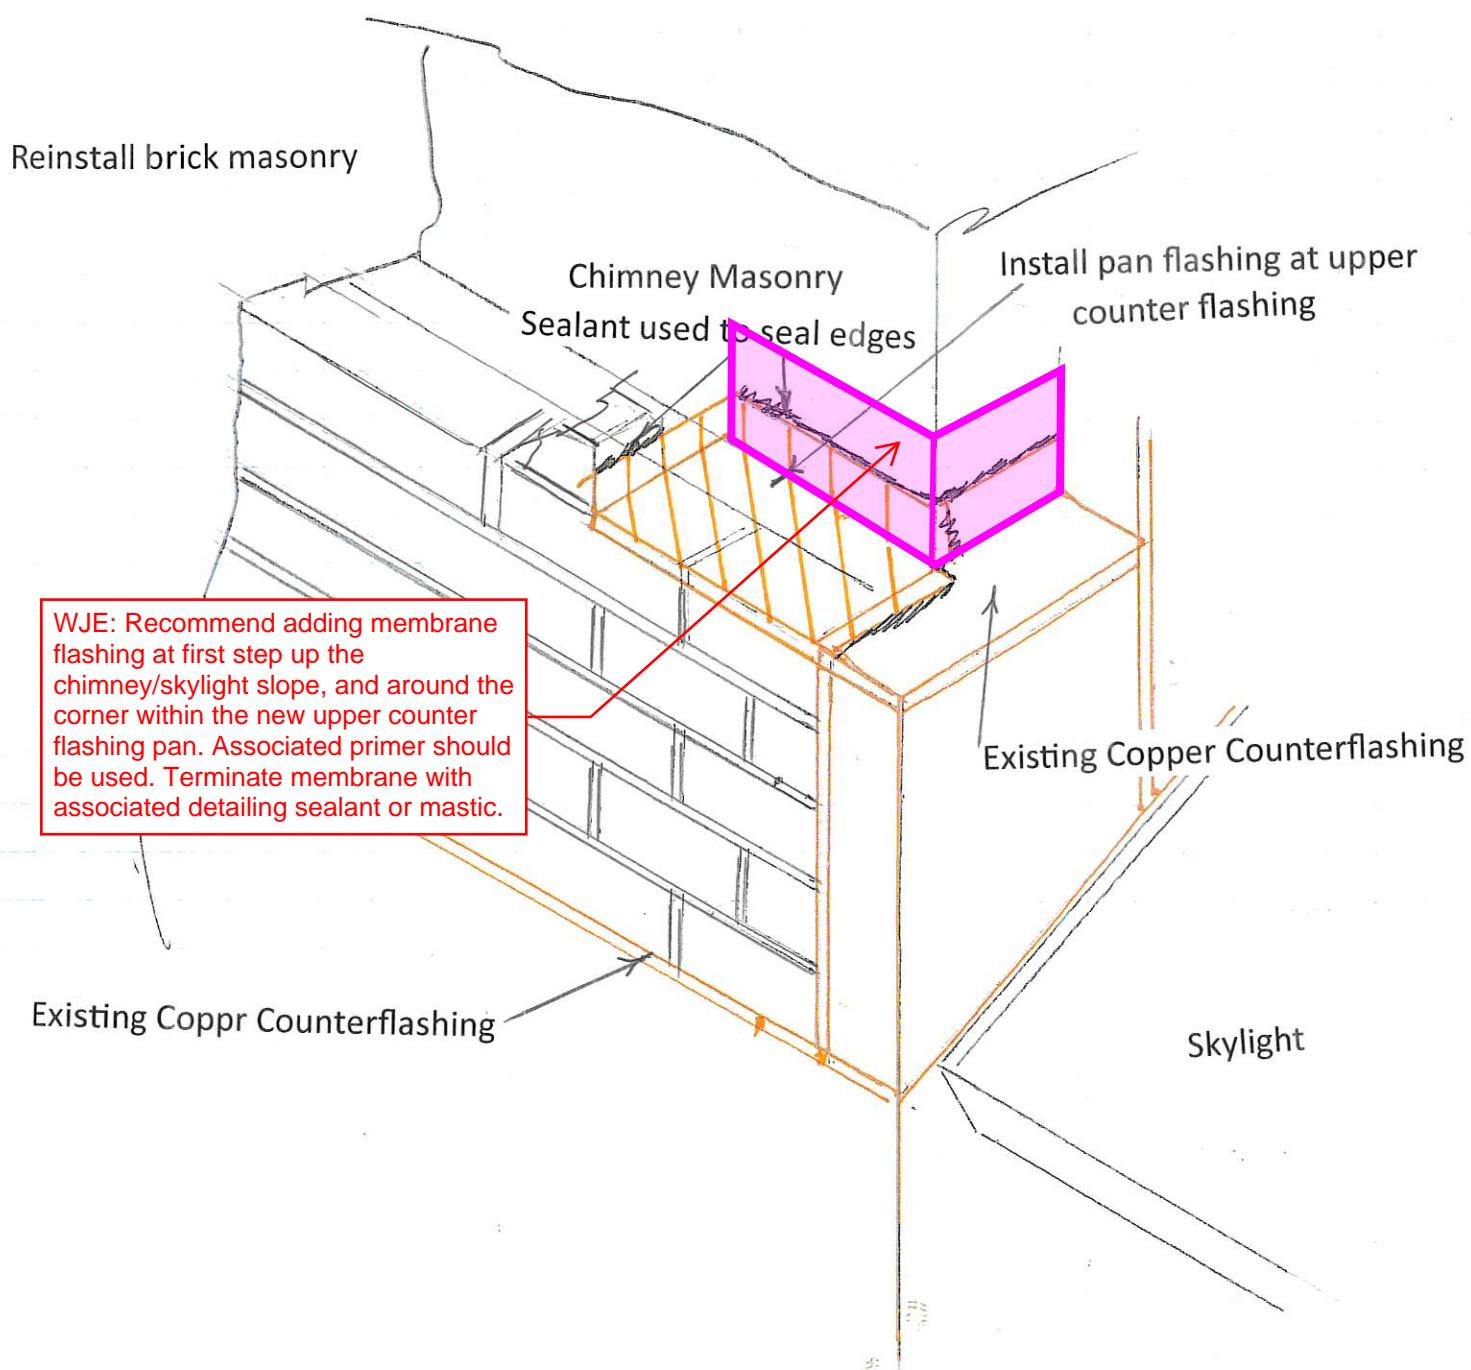
SKETCH 5 ADDITIONAL FLASHING STEP 3

West Chimney-South Side

WJE: Recommend adding membrane flashing at first step up the chimney/skylight slope, and around the corner within the new upper counter flashing pan. Associated primer should be used. Terminate membrane with associated detailing sealant or mastic.
