**Re: Wetland and Vernal Pool Inspection Report  
Apple Hill Estates - 31 Hunting Lane, Sherborn, MA**

## 1. Introduction

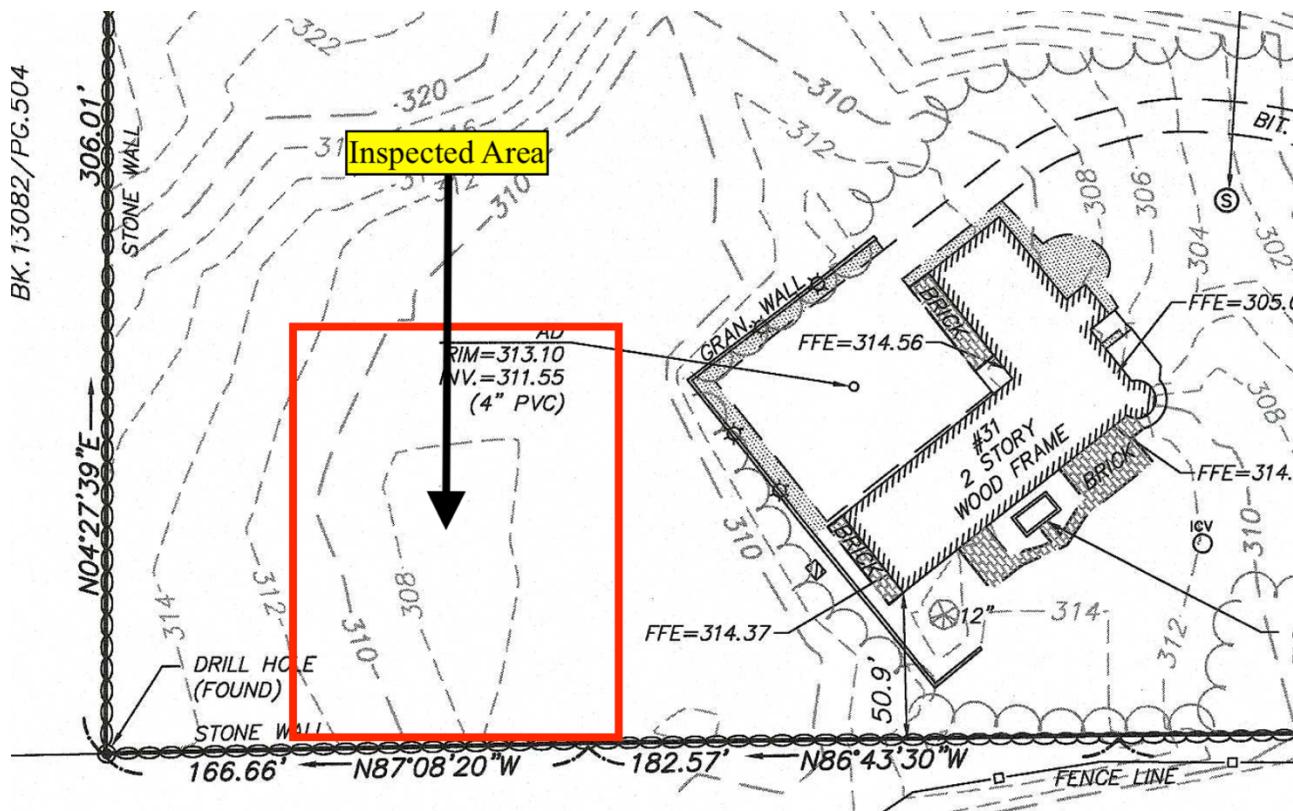
Figure 1 - Area surveyed for vernal pool habitat.

On April 30, 2021 I performed an inspection and vernal pool survey within a small, isolated depression located to the east of the existing dwelling at 31 Hunting Lane in Sherborn (Figure 1).

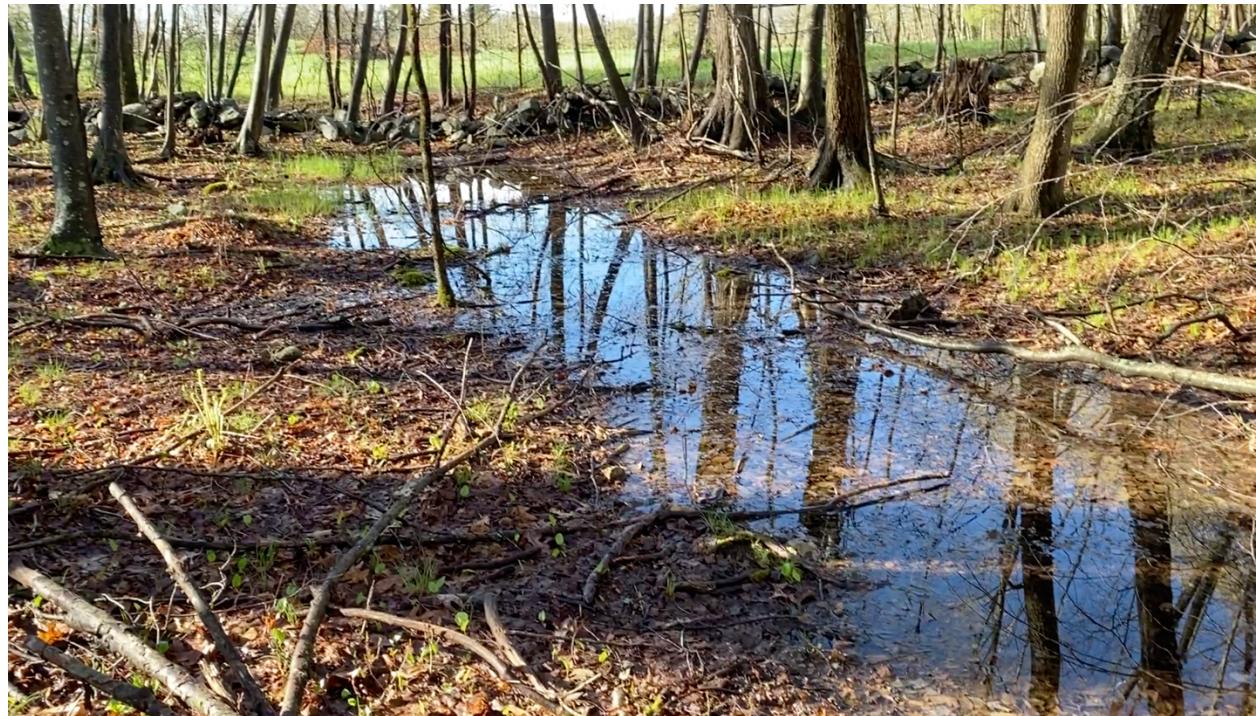
The inspection and survey took place the morning after a significant rainfall event, so the depression was flooded with clear water, up to four inches deep. Photos 1-3 show the depression as observed on 4/31/21.

*Photo 1 – Southern half of flooded depression, facing south (4/31/21).*

- The pond had shallow standing water, ranging from approximately 1-4 inches deep, on the morning after a significant rain event.
- The depression is not mapped as a “Potential Vernal Pool” on the NHESP GIS layer.
- I did not observe any evidence of breeding by obligate species (fairy shrimp, wood frogs or spotted salamander).
- I did not observe any other amphibians or their eggs or larvae.
- I did not observe any aquatic invertebrate that are commonly encountered in vernal pools, such as fingernail clams, amphibious snails, predaceous diving beetle larvae, dragonfly and damselfly larvae, etc.
- Volume calculations of the basin were prepared by Allen & Major (Figure 2). The volume of the basin when flooded was calculated to be 0.008 acre-feet or 360 cubic feet at a depth of 0.3 feet.

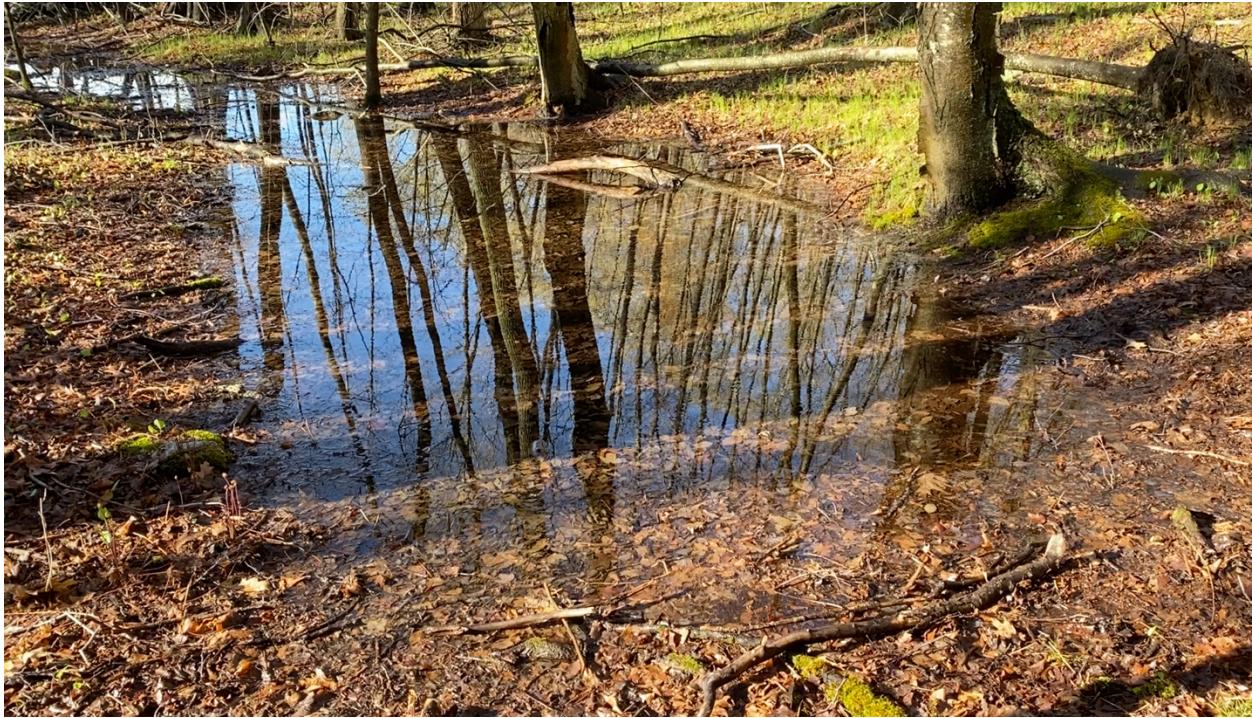
Photo 2 - Northern half of flooded depression, facing southwest (4/31/21).

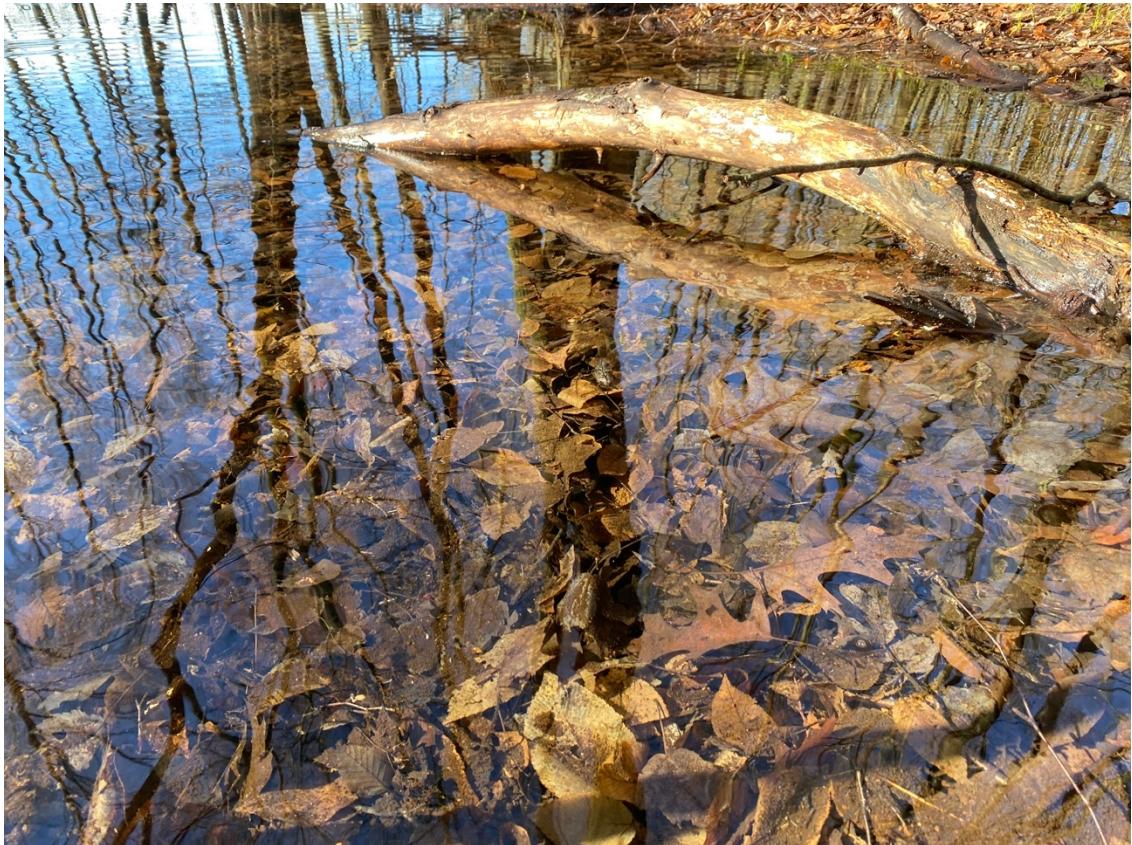
Photo 3 - Close-up view of clear water in flooded depression on 4/31/21

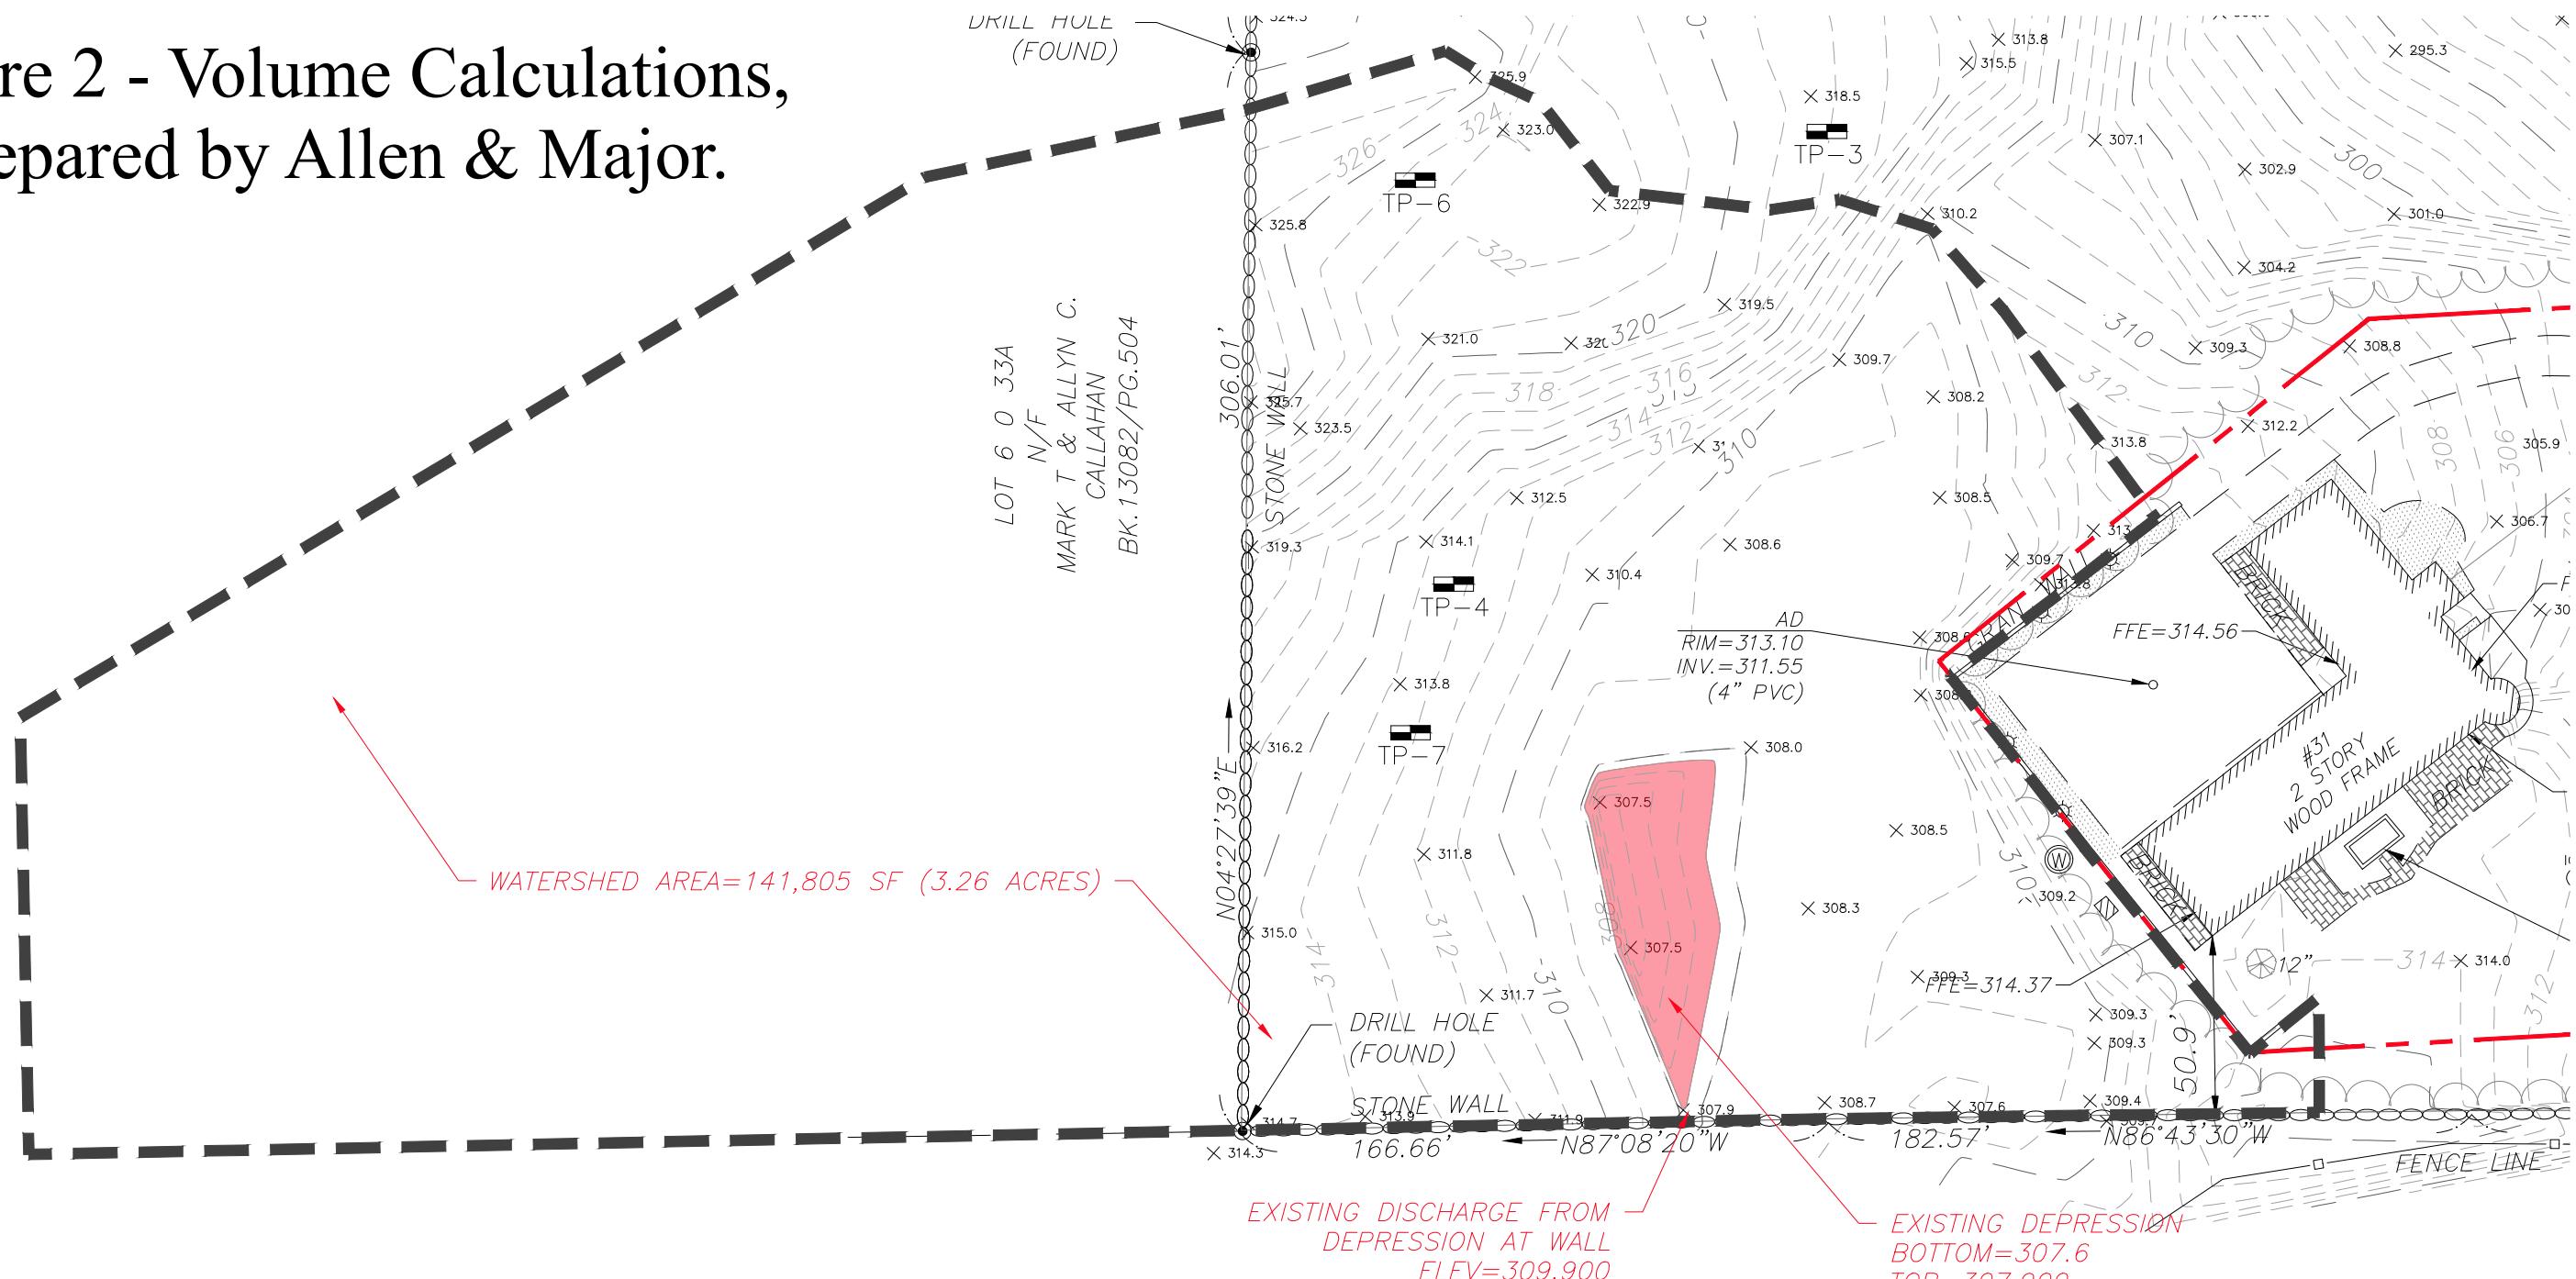
# Figure 2 - Volume Calculations, prepared by Allen & Major.

## Summary for Pond 1P: Existing Depression

Volume	Invert	Avail.	Storage	Storage	Description
#1	307.60'	0.008	af	Custom Stage Data (Irregular)	Listed below (Recalc)
Elevation	Surf.Area	Perim.	Inc.Store	Cum.Store	Wet.Area
(feet)	(acres)	(feet)	(acre-feet)	(acre-feet)	(acres)
307.60	0.006	111.221	0.000	0.000	0.006
307.70	0.019	153.490	0.001	0.001	0.026
307.80	0.035	195.662	0.003	0.004	0.053
307.90	0.054	234.904	0.004	0.008	0.084

Volume	Invert	Avail.	Storage	Description	
#1	307.60'	360 cf	Custom Stage Data (Irregular)	Listed below (Recalc)	
Elevation (feet)	Surf. Area (sq-ft)	Perim. (feet)	Inc. Store (cubic-feet)	Cum. Store (cubic-feet)	Wet. Area (sq-ft)
307.60	261.360	111.221	0	0	261.360
307.70	827.640	153.490	52	52	1,151.856
307.80	1,524.600	195.662	116	168	2,323.720
307.90	2,352.240	234.904	192	360	3,668.455

The calculated volume of the basin does not meet either of these definitions, therefore the basin is not a jurisdictional ILSF under the WPA or Wetland Bylaw.
