Lot 3 Farm Rd 11/9/21
PM
Deshong Wang PE
Murchison- DWQE/RSE

55 Farm

65 Farm Road

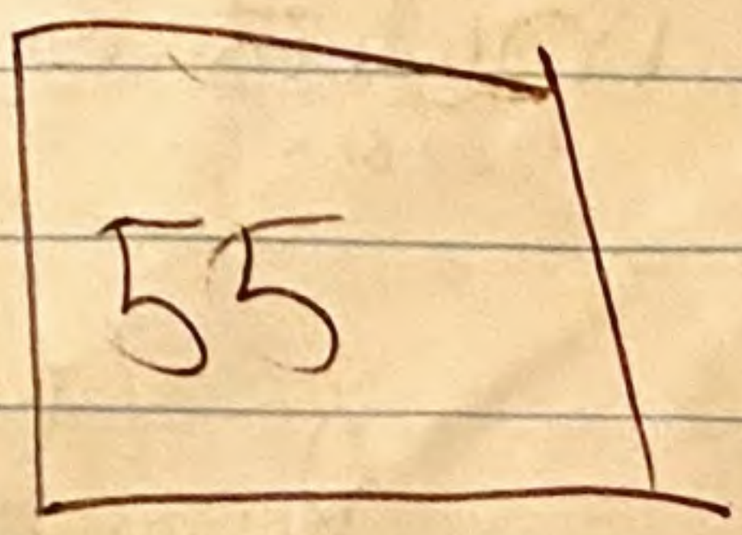
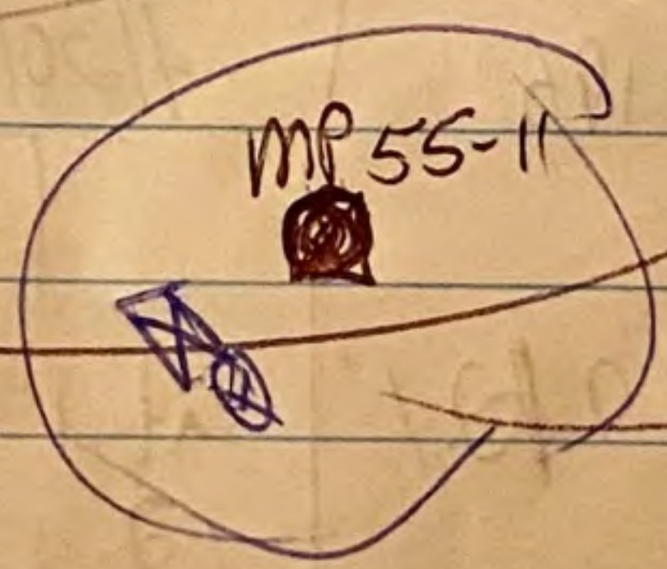
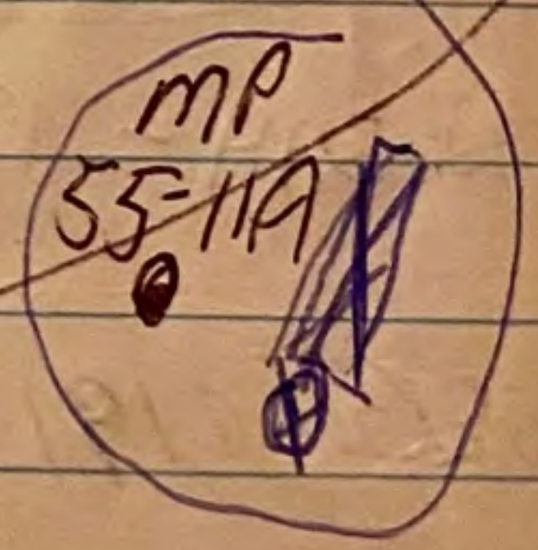
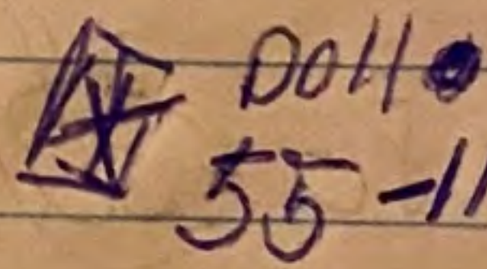
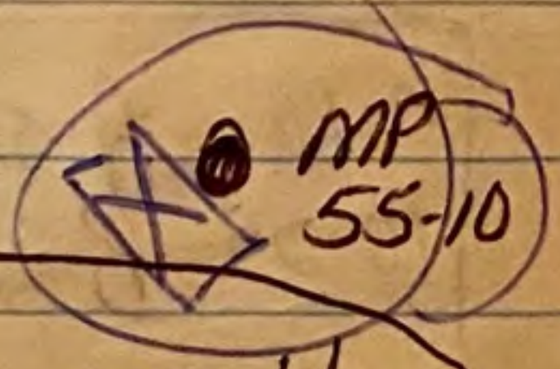
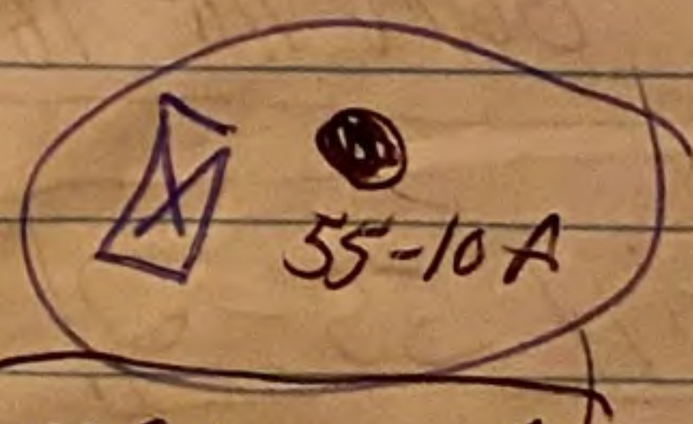
55 Farm Road | 04.26.21

Back of House
