Re: Town of Sherborn – Sherborn Library Project  
December 28, 2016 Construction Contract (Five Star Building Corporation)  
June 15, 2020 Takeover Agreement (Travelers Casualty and Surety Co. of America)  
Performance Bond No. 007-SB-106605907 (Travelers Casualty and Surety Co. of America)  
Notice of Unfair/Deceptive Acts/Practices and Demand for Relief – G.L. c. 93A, § 9

## ARCHITECT'S FIELD REPORT

| <b>PROJECT:</b> SHERBORN LIBRARY Renovations & Addition | <b>FIELD REPORT NO:</b> 49 |

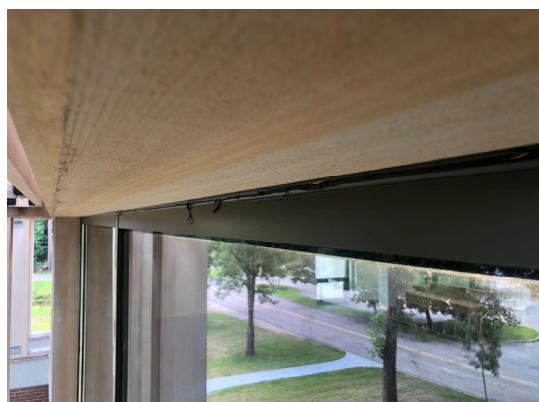
Line 1 CW H-J: Snap on cover cannot be removed. 1. The cedar board of the horizontal soffit butts to the top face of the aluminum curtainwall frame @ the north side jamb. 2. The cedar board butts +/- 1/4" below the top of the aluminum curtainwall frame at the far south side jamb. 3. There is no head joint/reveal for the primary sealant. The cedar board butts directly to aluminum curtainwall frame and the sealant/residue is only left on the aluminum curtainwall frame.
