118 Mill Street

James Leland House or Hopestill Farm, November 1998

Form Nos.	76 house, 274 barn, 937 mill
Area	
Town	Sherborn
Address	118 Mill Street
Assessor's Map	8/82
USGS Map	Medfield
Historic Name	James Leland House or Hopestill Farm
Uses: Original	Residence
Present	Residence
Ownership, 1981	Robert Leland
" Original	James Leland
Constructed	House in 1939, barn ca. 1830, sawmill ca. 1939
Source	James Leland
Style/Form	Saltbox
Architect	
Ext. Wall Fabric	Wood shingle
Outbuildings	Barn, shed
Alterations	Third house to occupy this site, second house, built 1730, burned in 1939.
Moved	No
Acreage	16.80 acres

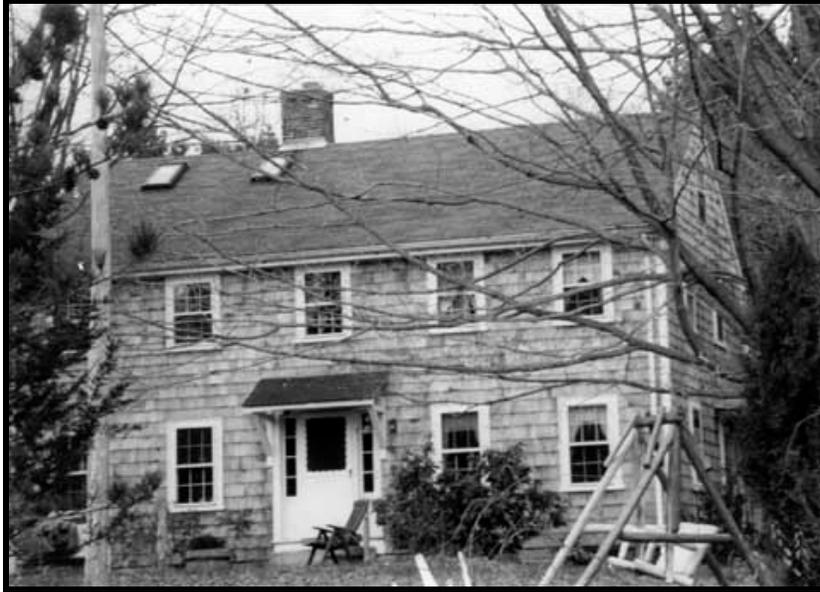
The house at 118 Mill Street (**#76**) survives as it is described on the survey form completed in 1981. No major changes have been carried out since that time.

The barn on Hopestill Farm is a large, gable-front, two-story building clad in wood clapboards (**#274**). The single large opening at ground level in the south-facing facade has paired rolling doors hung from an exterior track covered by a simple hood. A single-pane window occupies the gable peak. Other windows are fixed six pane sash and a row of tall 2/2 sash on the west elevation that may have been intended to act as a greenhouse. The roof is clad in asphalt shingles and the foundation, consisting of piers in the northwest corner, is built of uncut granite. The facade of the barn and the front door of the house face one another and create a south-facing door yard.

Behind the barn at Hopestill Farm is the mill (**#937**), built around 1940. This consists of four poles supporting a metal roof that covers what looks like a historic and operational sawmill. The pile of sawdust, log moving equipment and piles of logs combine to give the appearance of an old-fashioned mill yard.
