44 South Main Street

William J. Coombs House

Form Nos.	132 house, 332 coop, 333 garage, 334 barn
Area	
Town	Sherborn
Address	44 South Main Street
Assessor's Map	11/141
USGS Map	Medfield
Historic Name	William J. Coombs House
Uses: Original	Residence
Present	Residence
Ownership, 1981	Charles Blank
" Original	J. William Coombs
Constructed	House in 1890, barn ca. 1890, chicken coop ca. 1900, garage ca. 1930.
Source	Margaret Dowse Buntin's file
Style/Form	Late 19th century frame vernacular
Architect	
Ext. Wall Fabric	Clapboard
Outbuildings	Barn, henhouse
Alterations	Rear wing probably early 20th century
Moved	No
Acreage	5.19 acres
Setting:	Located close to road on well-maintained tree shaded lot, not far from Sherborn center to the North.

Recorded June-July 1981, by Edward W. Gordon
Updated 1999, by Sanford Johnson

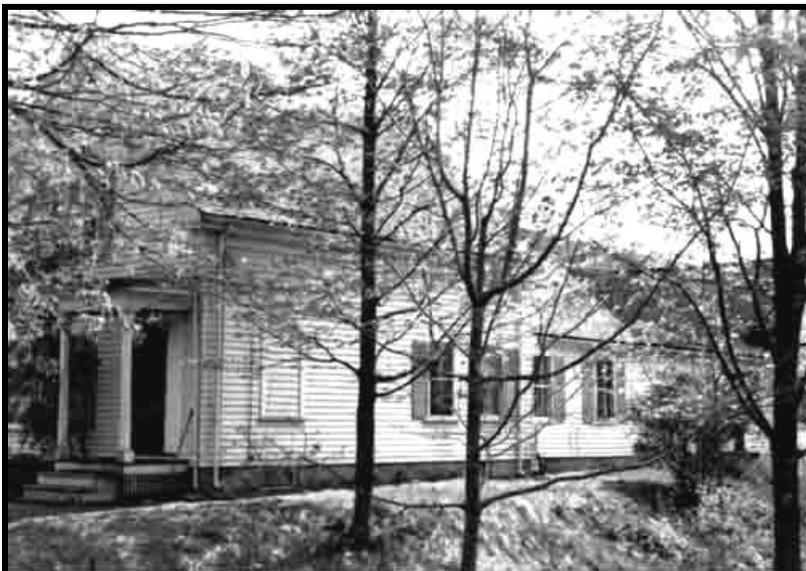
This residence is composed of a 1 1/2 Story main block and long, rambling rear wing. In terms of massing, fenestration and surface treatments it seems more like an 1850's or 1860's cottage than a house built in 1891. Perhaps it was moved.

The house at 44 South Main Street (**#132**) survives as it is described on the survey form completed in 1981. No major changes have been carried out since that time.
